CONVOYS WHARF
Prince Street
London SE8

Evaluation report

April 2010

Site Code: CVF10

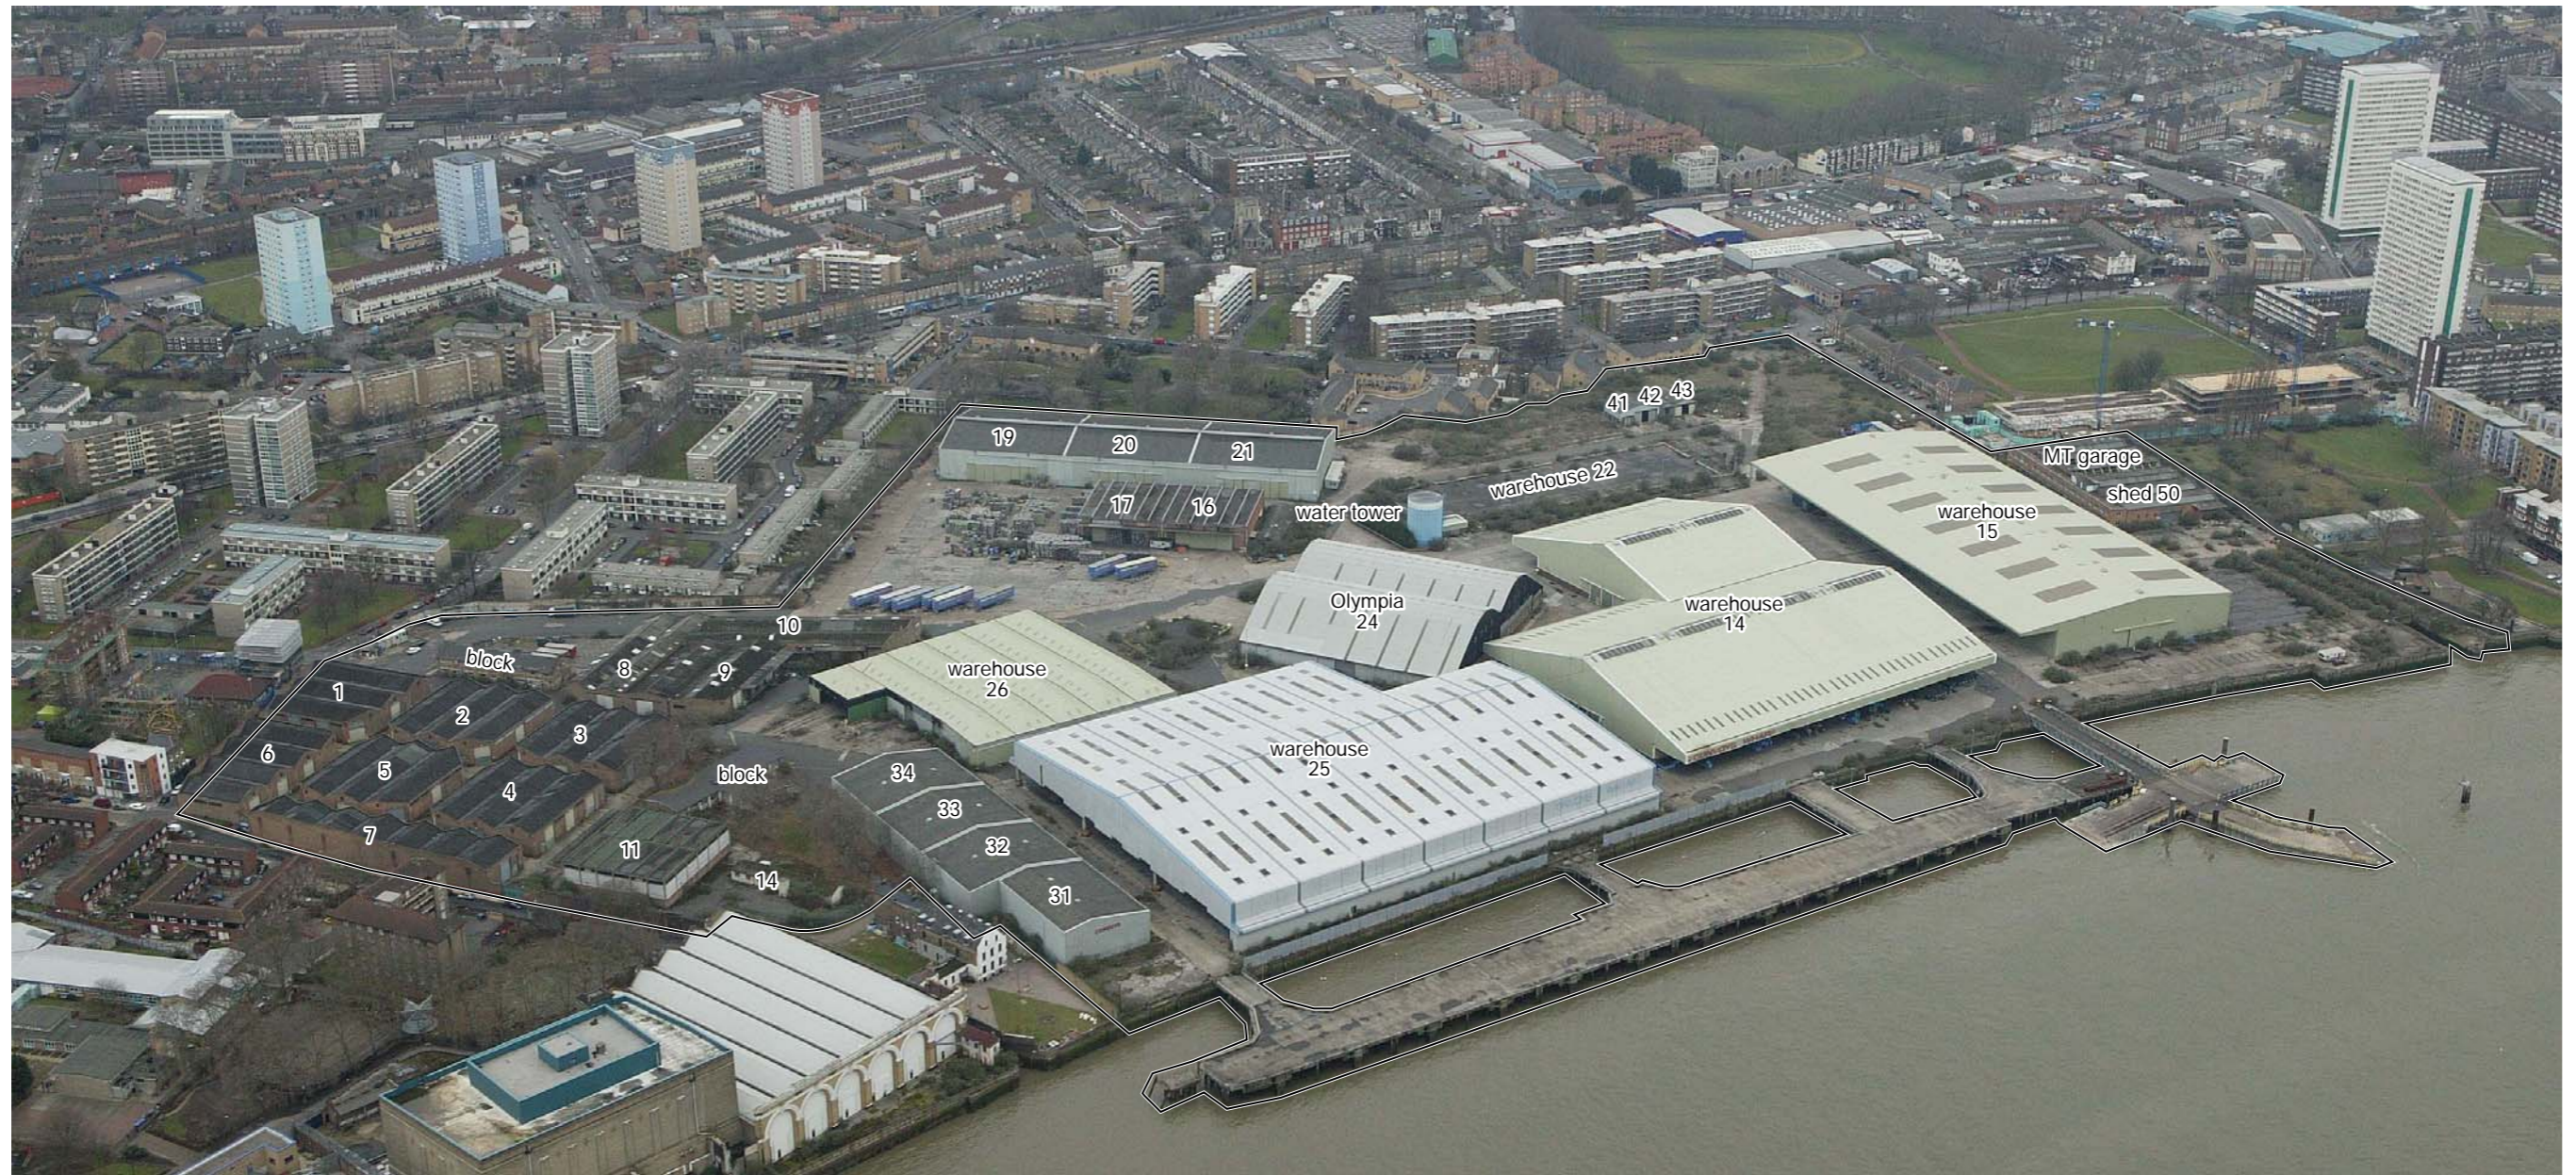
Fig 4 Convoys Wharf from the air, looking west, with Warehouse numbers marked

The evaluation took place at Convoys Wharf, Deptford, Lewisham, hereafter called 'the site' (Fig 1, Fig 4). The site is bounded by the Thames to the northeast and by Watergate Street to the east, Prince Street, Sayes Court to the south, and to the west the rear of properties in Dacca Street and Grove Street, and Leeway to the east. The Ordnance Survey National Grid Reference for centre of site is 537000 178200. The level of the slab varied between c 3.3m OD in the west part of the site to c 5.0m OD in the north. The site code is CVF10.

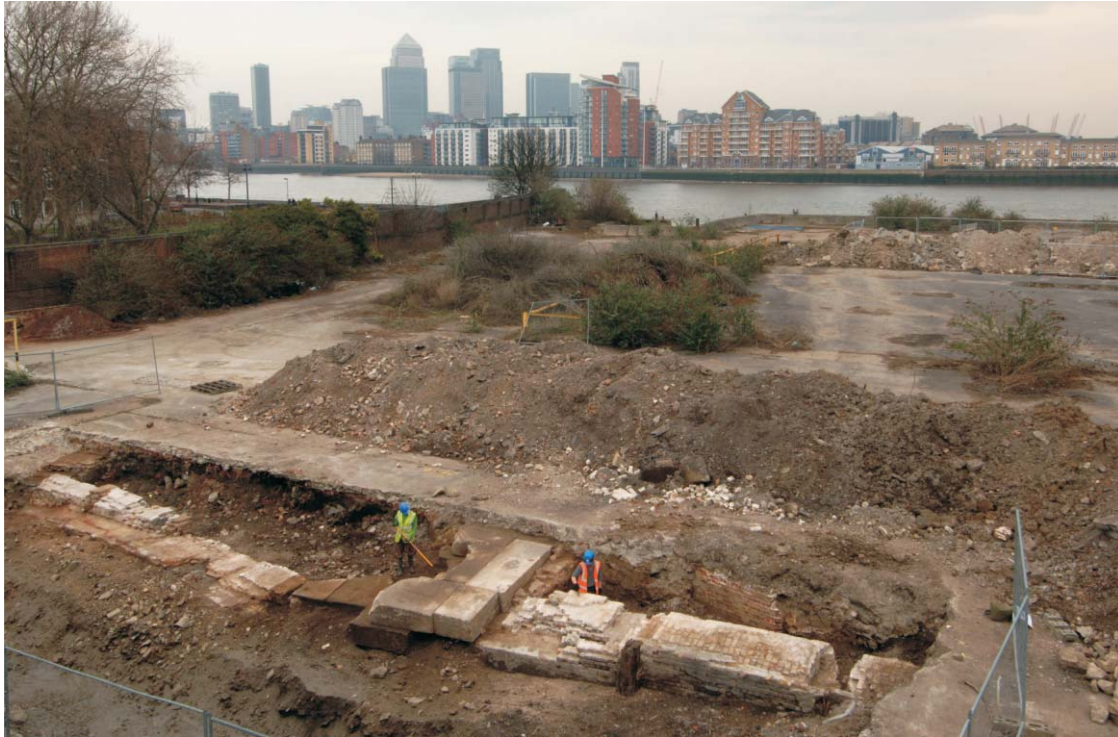
Fig 6 The Great Mast Pond wall in Trench 1, looking north

The openings in the walls may have held horizontal supports that braced the walls against the weight of the ground behind them. The removal of these supports may explain the severe slumping into the Mast Pond. The openings in the southwest part of the Mast Pond wall corresponded to two timber fenders [551] and [547]. A brick surface was observed to the east of the Mast Pond wall, at 2.89m OD, and a stone base [975] (Fig 9), perhaps part of a crane base, at 3.06m OD.

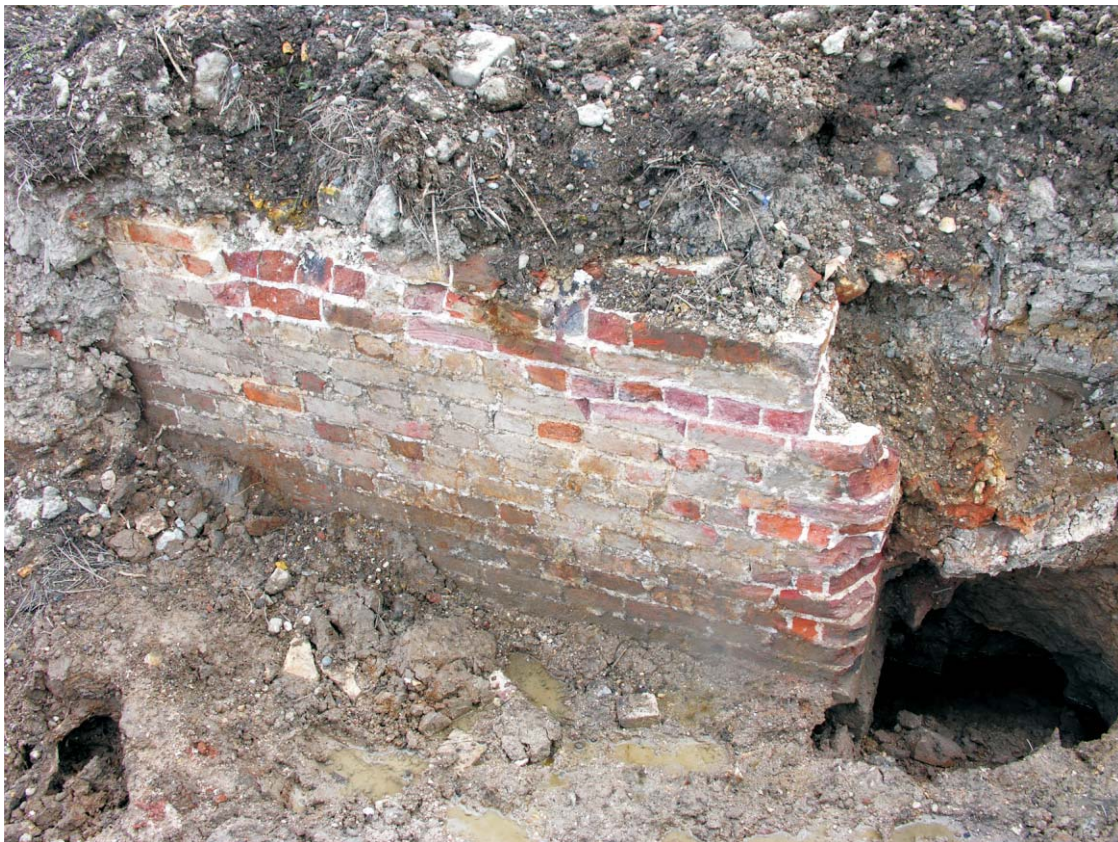
Fig 7 Wall [548] in Trench 1, looking north

A further wall [548] (Fig 7) was identified in the trench edge in the south corner of the trench, built of red and orange brick set in white mortar. In the 1808 map, a canal is shown connecting the Great Mast Pond to the Small Mast Pond, and this may correspond to wall [548]. The wall survived to a height of 4.06m OD.

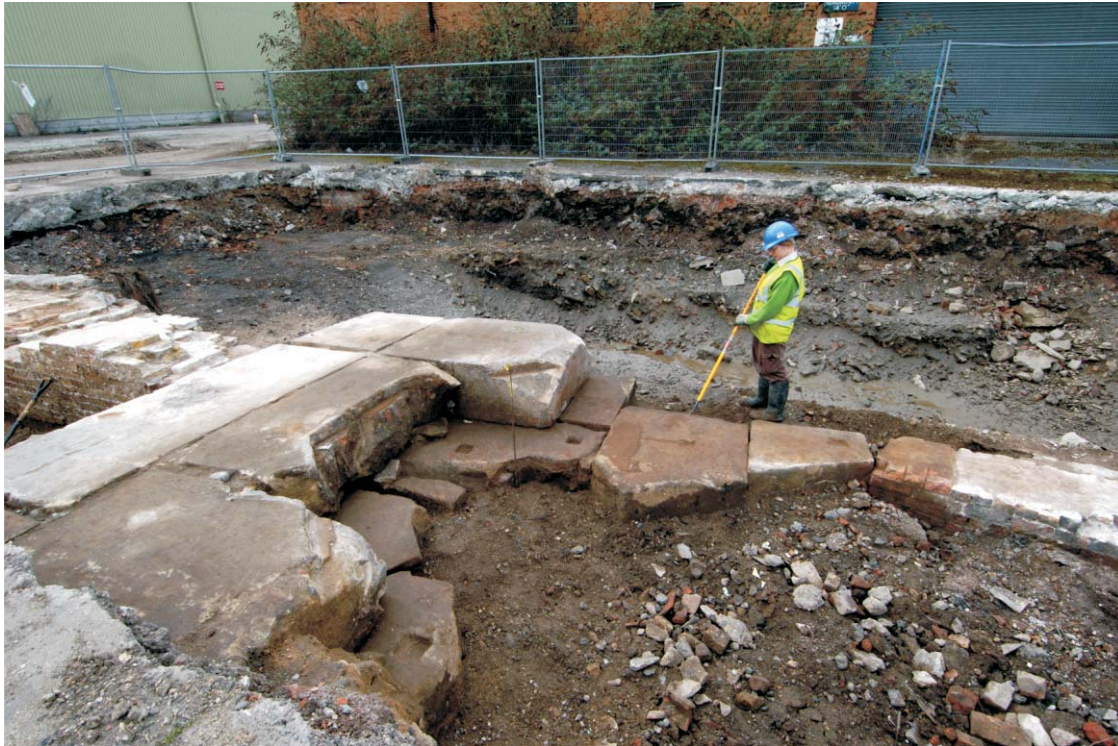
Fig 8 Capstan base [555] in Trench 1, looking south

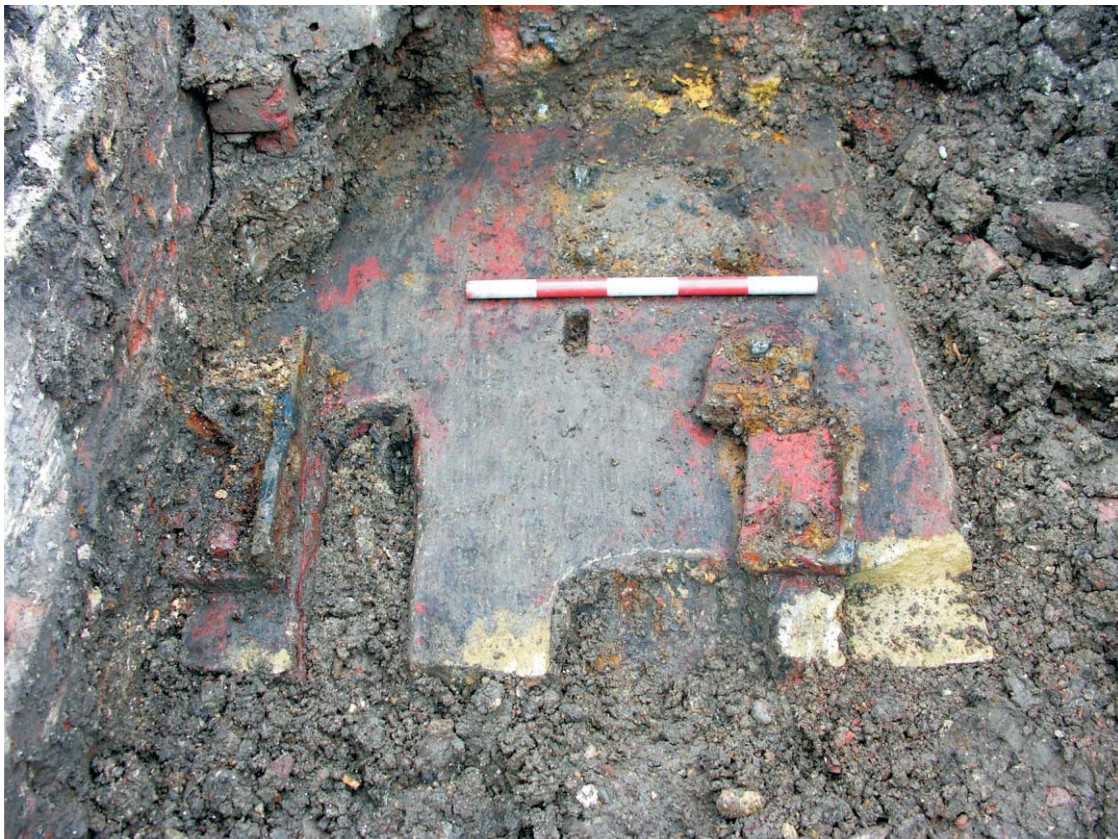
Fig 9 Stone base [975] in Trench 1, looking northwest

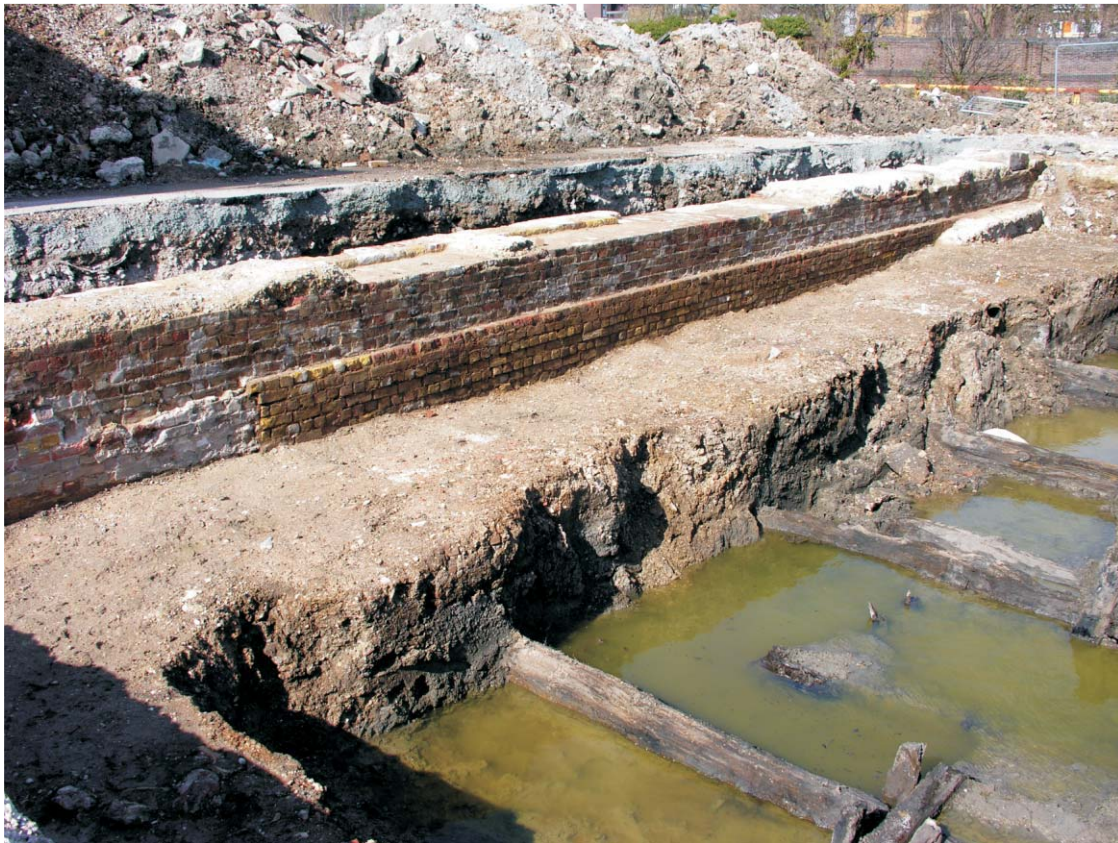
Fig 11 Trench 3, looking west

The principal structures in Trench 3 (Fig 10, Fig 11) consisted of a northwest-southeast running wall, interpreted as the Small Mast Pond wall, and, in the central part of the trench that was excavated deeper, a series of timber tie-backs associated with the timber predecessor to the Small Mast Pond wall.

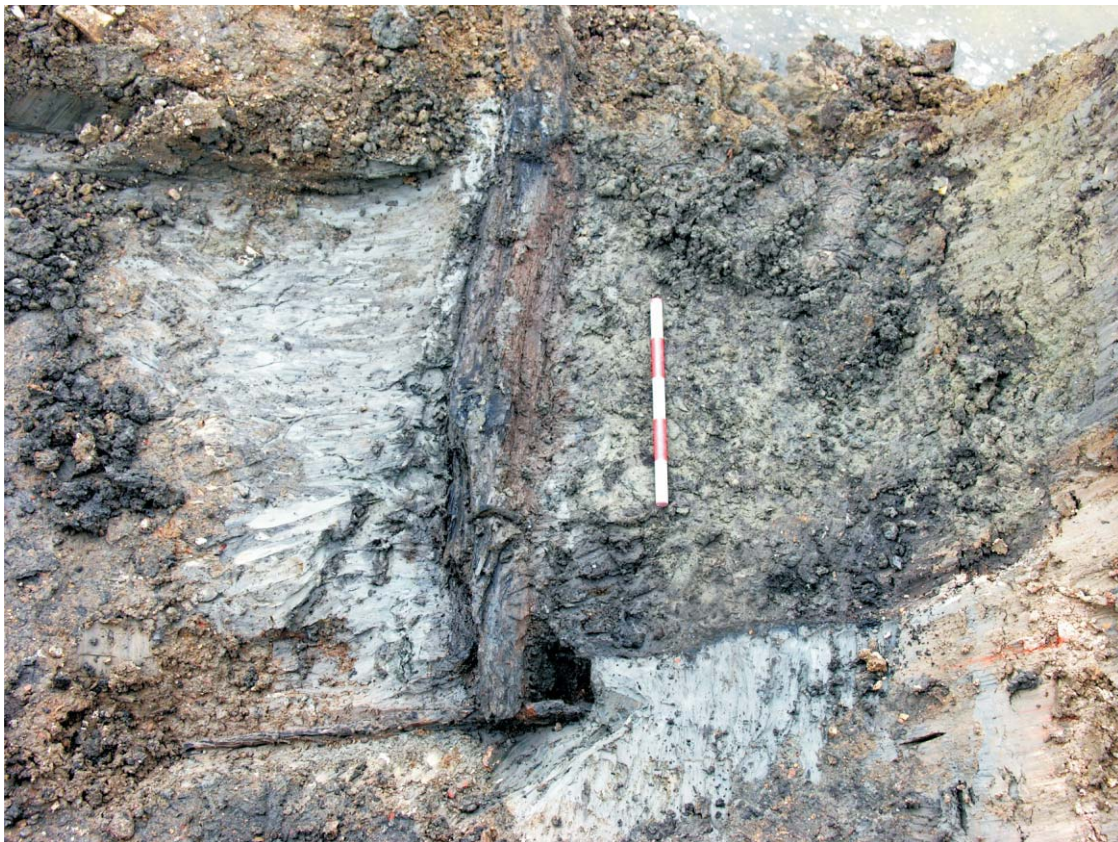
Fig 12 Tie-back [708] and early Small Mast Pond timber wall [942] (running from left to right) in Trench 3, looking northeast

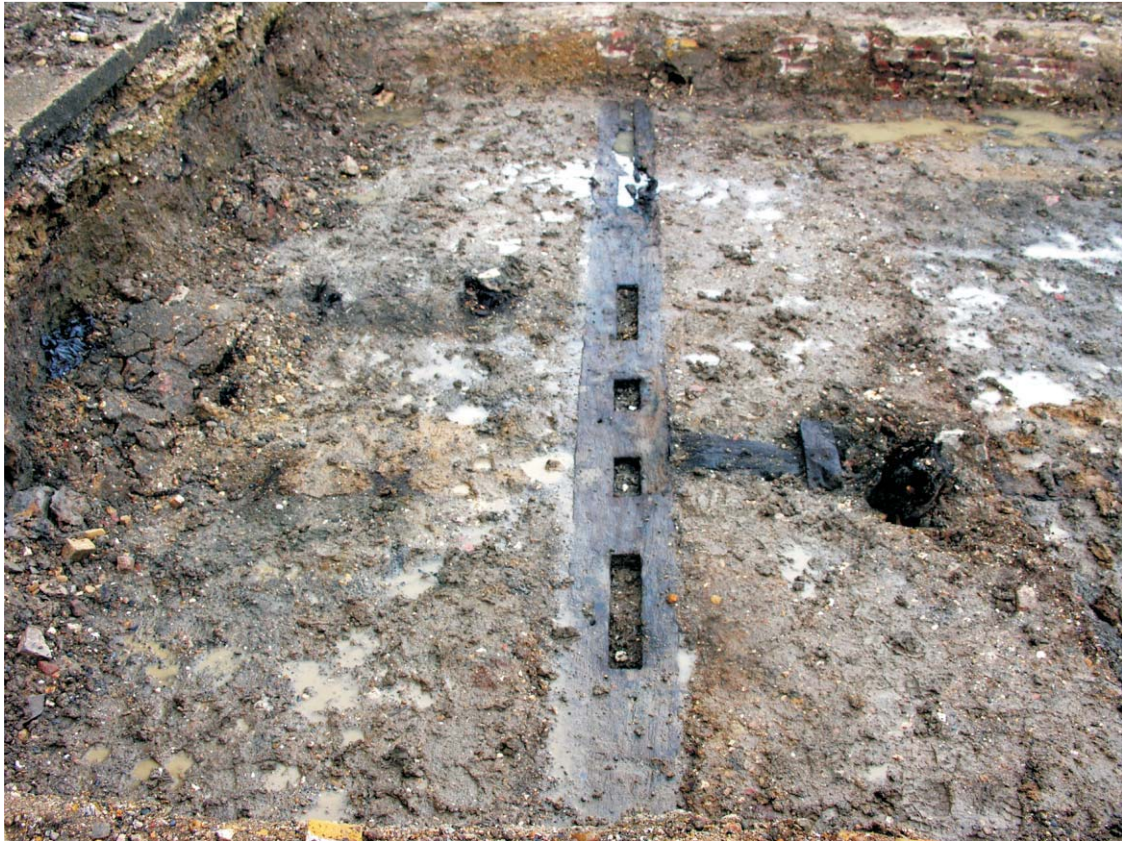
Fig 13 Timber baseplate [727] in Trench 5, looking northwest

and ran northwest-southeast (Fig 13). It is likely that this second-hand timber was reused as a foundation beam for a building fronting the Thames. An oak post base near the sill beam [729] had been wedged in place by ramming chocks against the sill beam. Beneath these timbers lay decayed traces of a revetment [728] running at right angles to the sill beam at 3.58m OD, towards the river. This comprised planking on edge with regular, small, squared uprights with clay packed around them implying that the plank sheathing was nailed on the fronts of the posts, common from the 17th century along the Thames (Damian Goodburn pers comm.). The heads of several oak piles could also be seen forming no clear pattern.

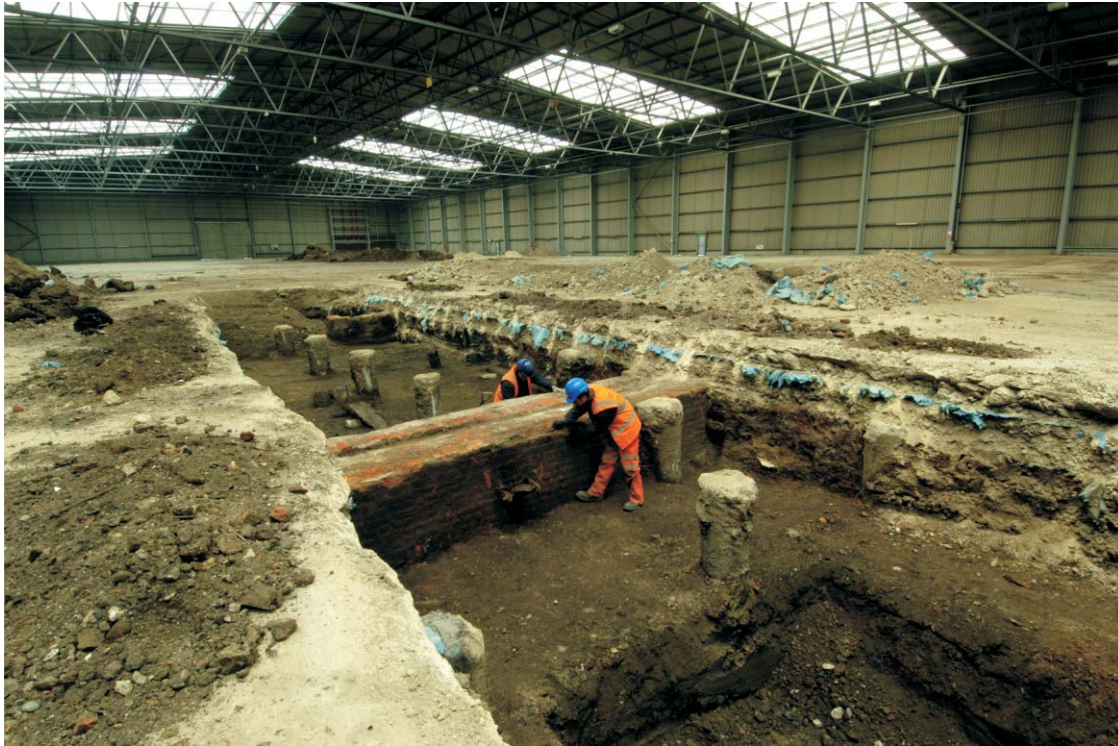
Fig 15 Small Mast Pond wall [402] in Trench 7, looking west

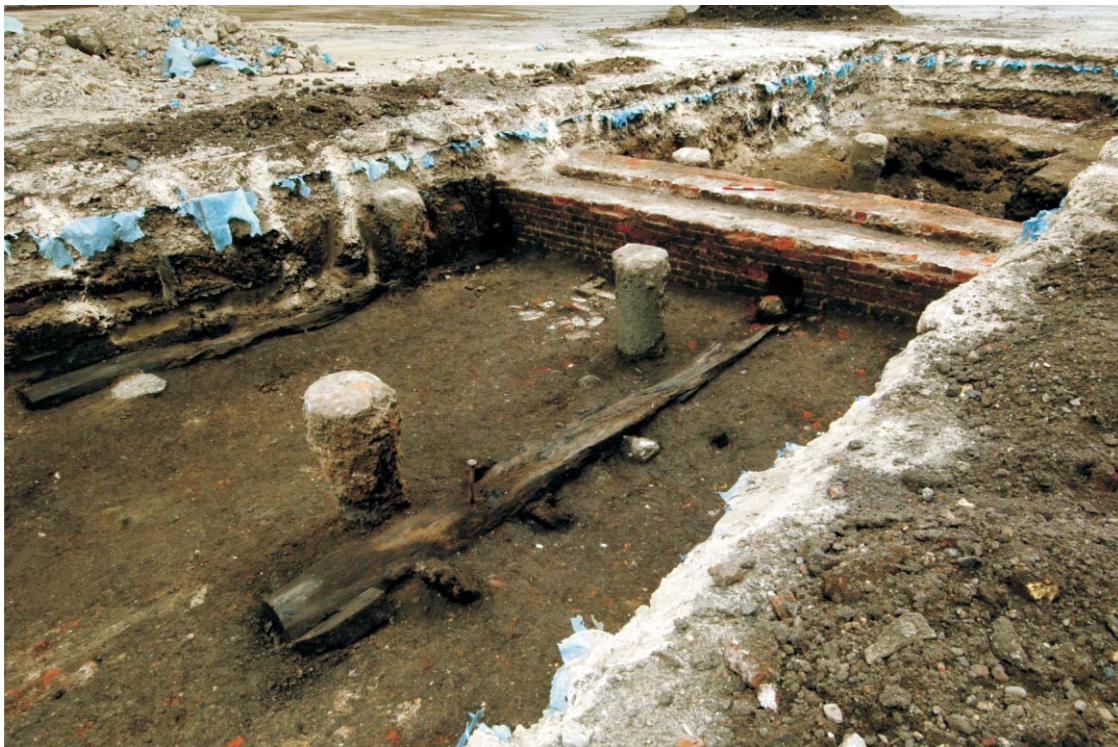
Fig 16 Small Mast Pond wall [402] and timber tie backs [431] and [429] in Trench 7, looking north

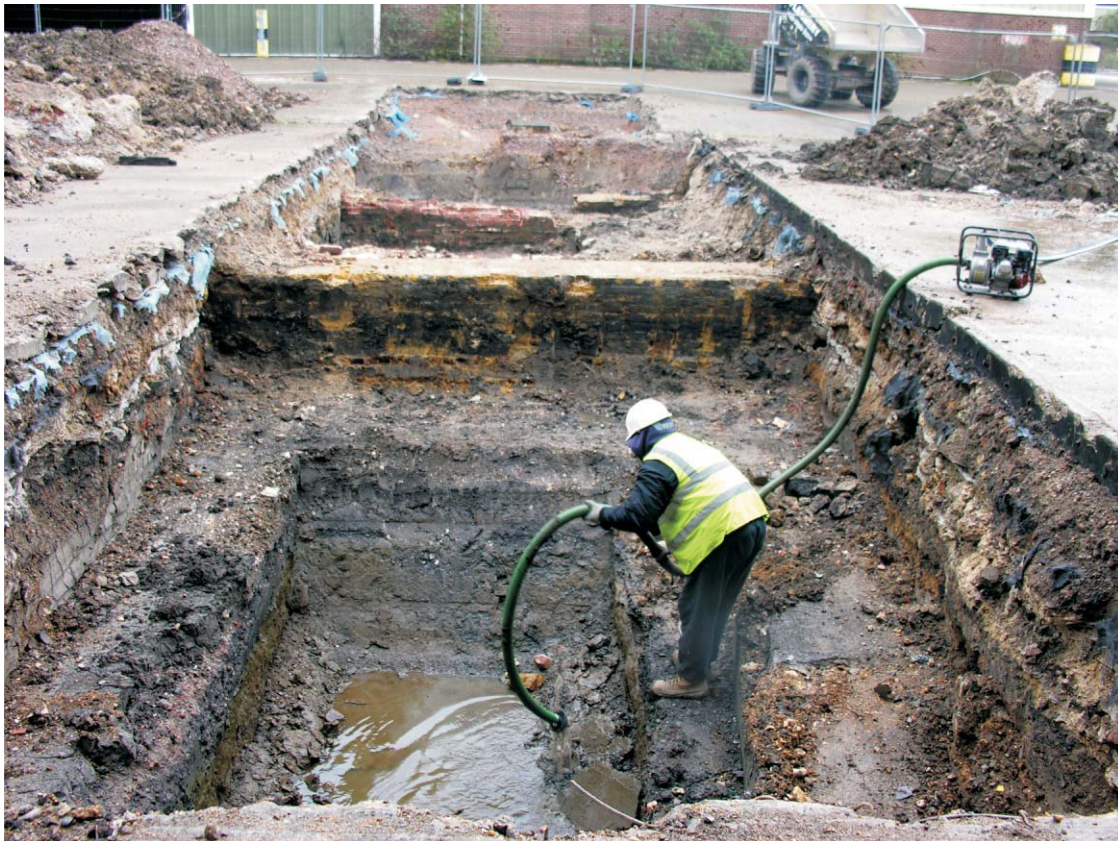
Fig 17 Trench 9, looking southeast

An early structure observed in Trench 9 (Fig 14, Fig 17) was a timber baseplate [977] at 3.05m OD. This lay below but was not on the same line as overlying a brick wall [655], suggesting the baseplate may originally have been the foundation to an earlier structure and had been reused. Wall [655] was built of red brick set in white lime mortar, its broken top lying at 3.88m OD. Wall [656] that was roughly parallel to wall [655] and built of purple-red bricks set in white lime mortar, was also supported on a timber baseplate at 3.22m OD. Wall [656] survived to a similar height to wall [655] and although its build was similar it was not identical. However, the two walls are likely to have been the external walls to separate but parallel buildings during the same period as an external, cobbled surface [978] at 3.69m OD abutted both walls. A more fragmentary wall [657] to the east of wall [656] was revealed in a deeper machine slot and survived only three courses high to 3.52m OD. Further east, the trench was heavily truncated by modern services, although another patch of cobbles [662] – also representing an external surface – was identified at 3.90m OD.

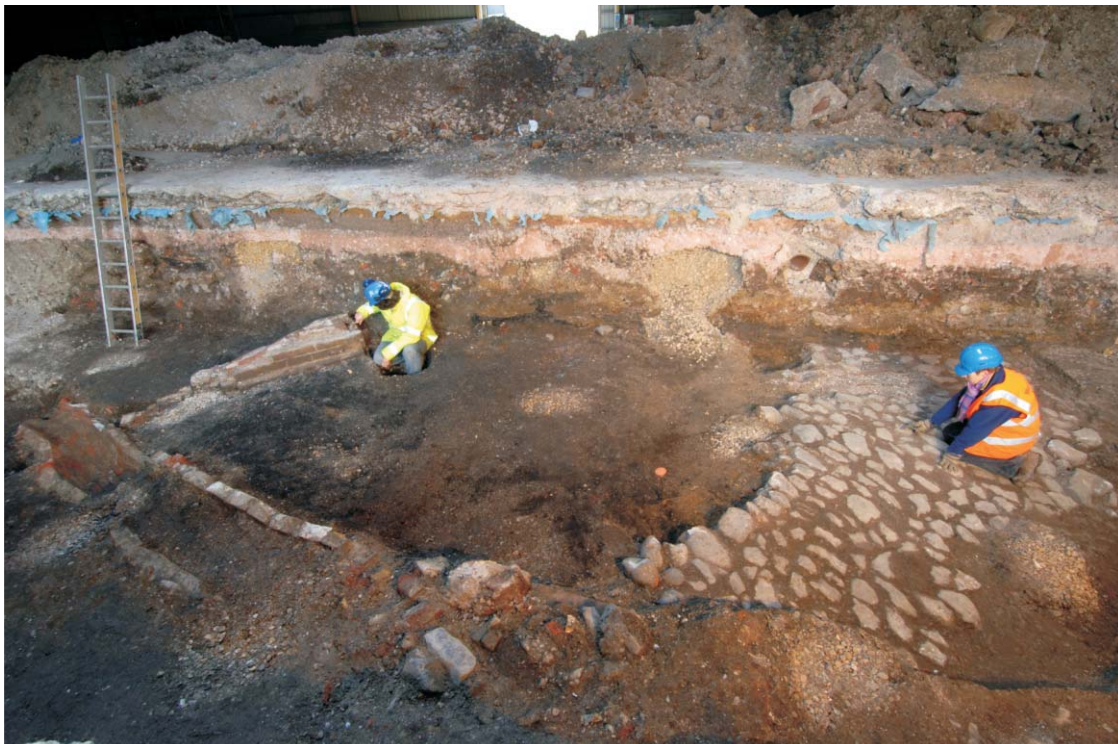
Fig 18 Steam kiln building [268] and cobbled surface [258] in Trench 10, looking southeast

In the central part of the trench, a north-south wall built of red brick set in lime mortar [268] rested on a timber baseplate [263] (Fig 18). The broken top of the wall lay at 3.68m OD. The wall is likely to have been part of the steam kiln known in this area of the site from map evidence. A cobbled surface [258] sloped away from the wall to the southwest, probably the result of subsidence, to a minimum height of 3.07m OD. The wall had been truncated by a brick culvert [265], built of frogged yellow bricks and reused unfrogged red bricks, set in brown sandy mortar.

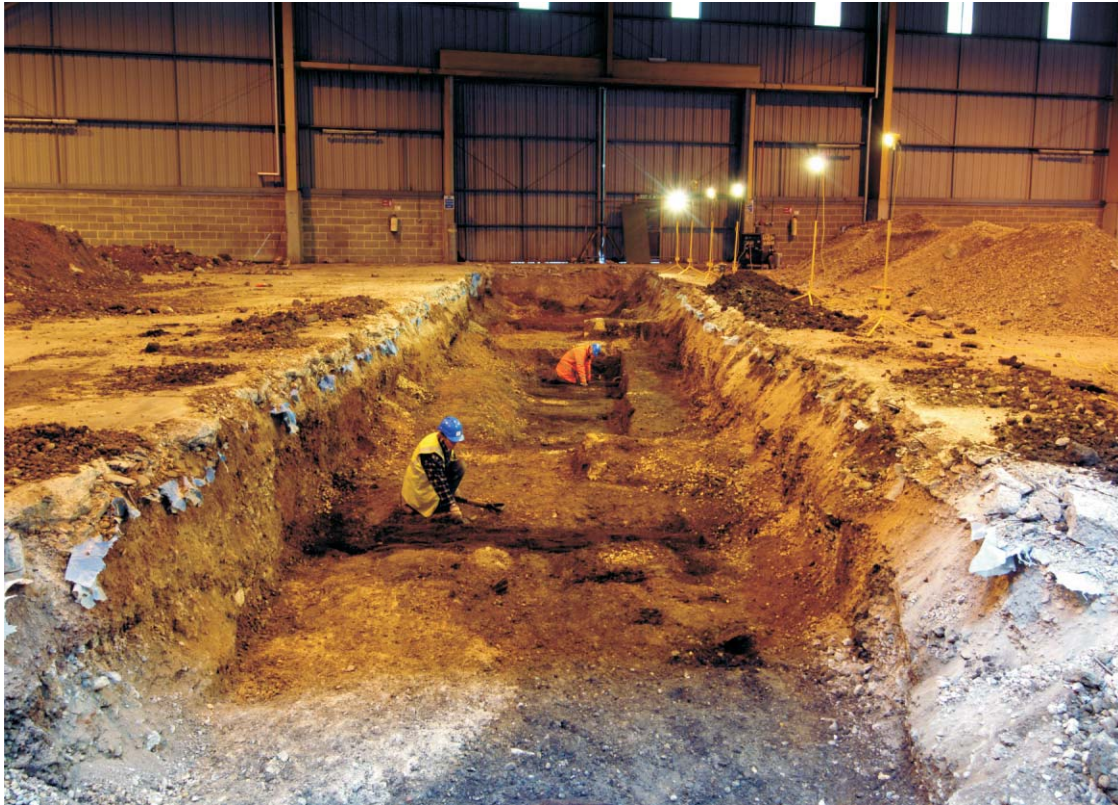
Fig 20 Trench 12, looking northeast

A series of timber beams [106] that crossed Trench 12 (Fig 19, Fig 20) were likely to be part of a slipway (Fig 21). The height of the timbers fell from 3.64m OD in the southwest end of the trench to 3.12m OD in the northeast end where the timbers were only exposed in a deeper machine slot. A machine slot in the northeast end of the trench was excavated to 3.07m OD but failed to locate any further timbers. The timbers consisted of substantial fast-grown oak beams and most likely dated to the 18th to early 19th centuries (Damian Goodburn pers comm.). Some iron spikes were visible in the timbers.

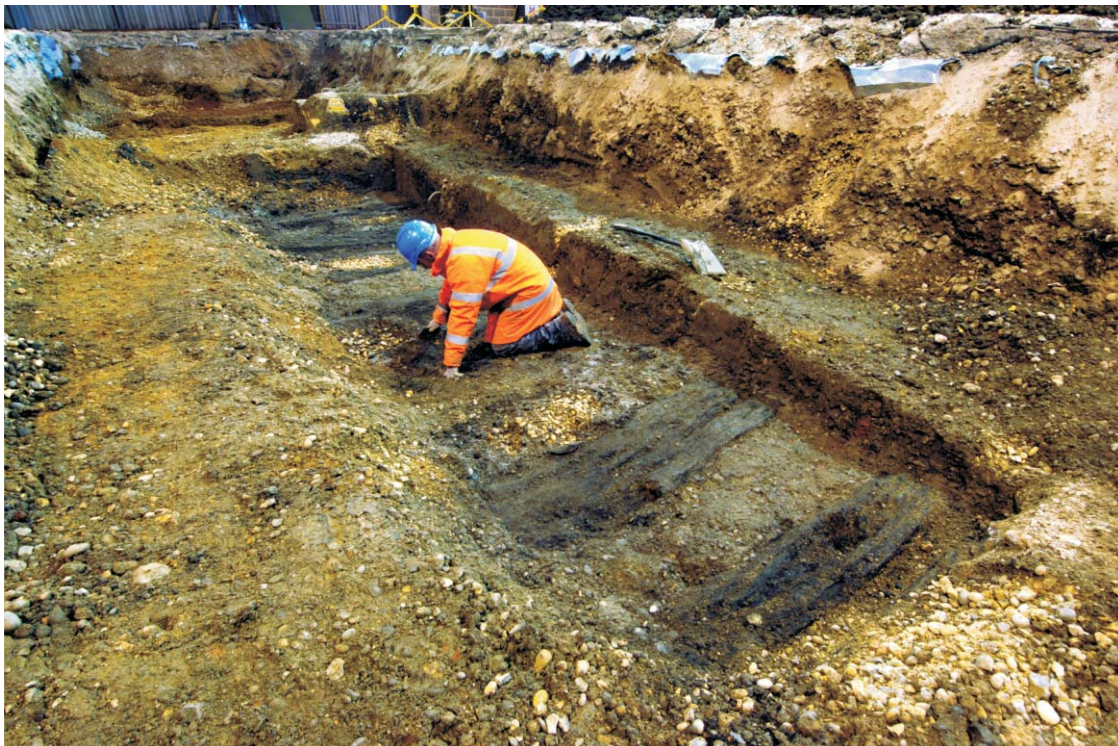
Fig 21 Remains of a timber slipway [106] in Trench 12, looking east

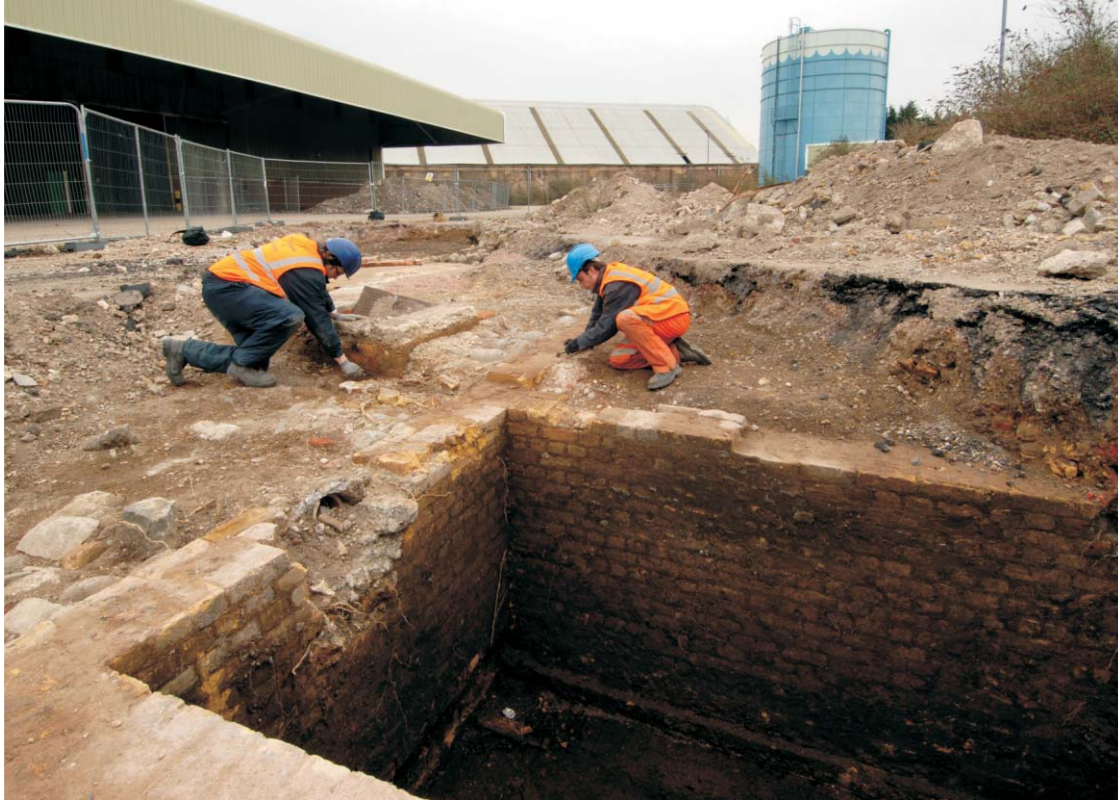
Fig 23 Brick sawpit [517] in Trench 15, looking east

Much of the archaeology in Trench 15 (Fig 22) had been truncated by modern services, although some structures were still visible. Brick walls [517] (Fig 23) were likely to be the brick linings for two saw pits and were built of frogged yellow bricks set in grey mortar. The top of the walls lay at c 4.10m OD, close to the modern ground surface. The western saw pit was excavated to the base of the brick lining at 2.11m OD. A recess set around the inside of the brick lining at 2.50m OD may originally have held a presumably timber floor. Cobbled surfaces [516], [518] and [520] abutted the edges of the walls and another patch of cobbles [512] survived further east.

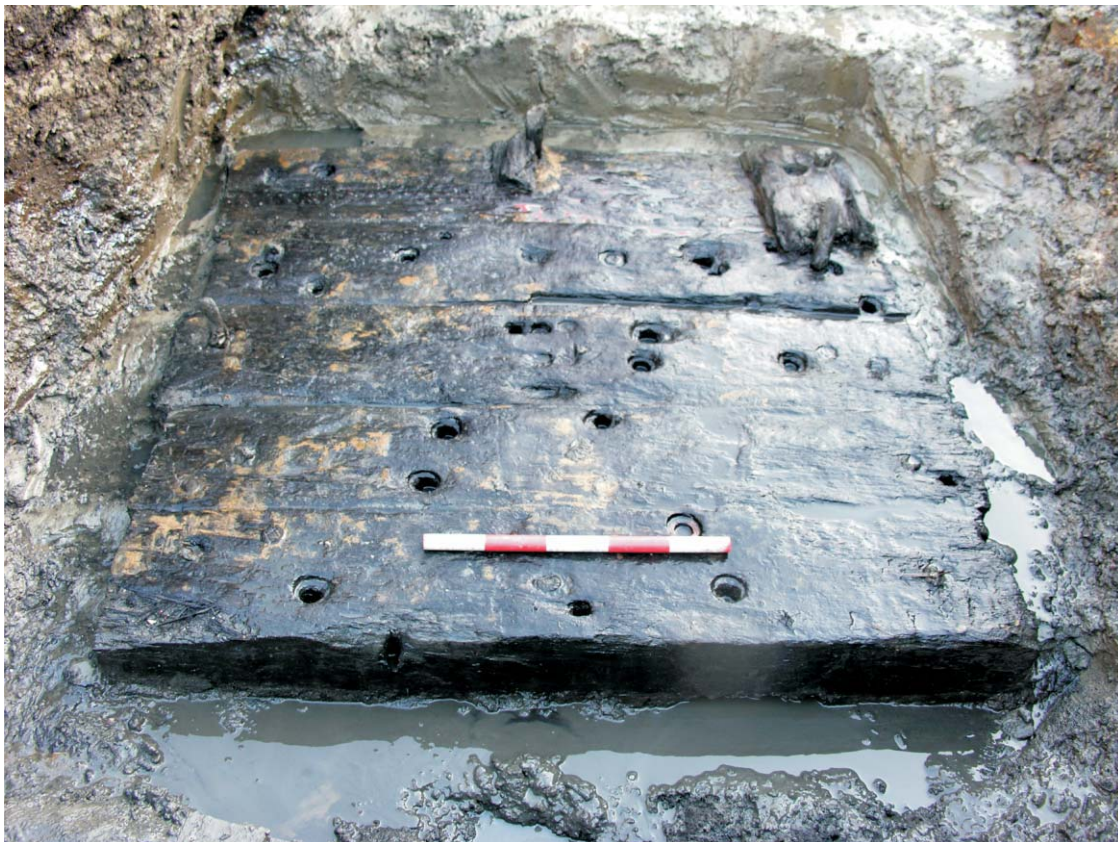
Fig 24 Timber platform [069] in Trench 16, looking south

Two timber platforms were found cut into the alluvium, [069] (Fig 24) in the south end of the trench and [077] in the centre. Both were similarly built, consisting of two layers of thick oak planks treenailed and bolted at right angles to each other. Platform [069] measured 1.64m by 1.46m its top at 0.93m OD, [077] was 1.50m square, its top slightly lower at 0.69m OD. In platform [069], the upper layer of timbers was decayed and had been roughly salvaged in the past, but the lowest was little decayed. The five planks or thin beams were probably longitudinal stringers or 'wale strakes' in a medium sized or largish carvel built ship. Relict features of ship origin included a small number of oak treenails, some of which were split and caulked. However, most of the fastening holes were clearly for the use of large 'clench bolts'. These ship fastening took the form of a round shaft with forged head on one end the other peened or 'clenched' over a washer. In one case the washer was left *in situ* and was seen to be of copper alloy. This would indicate the use of nonferrous bolts. One of the planks also had a double line of truncated copper nails, left from attaching copper sheathing of some kind (Damian Goodburn pers comm.).

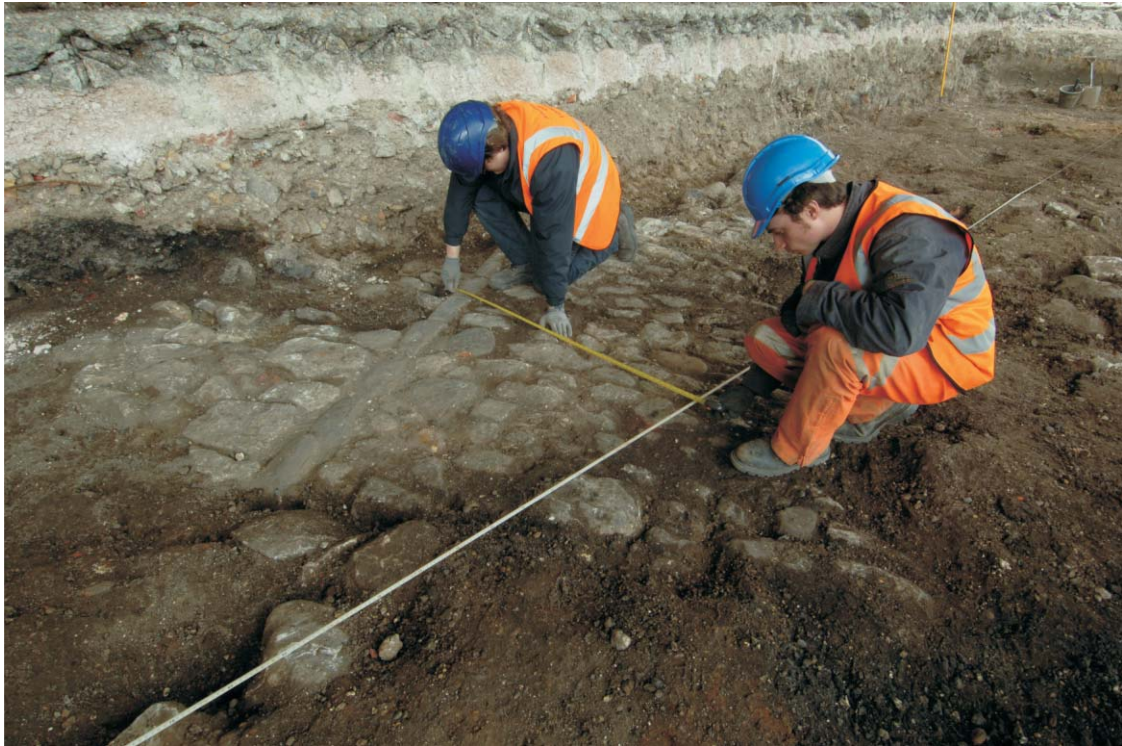
Fig 25 Cobbled surface [626] in Trench 17, looking northwest

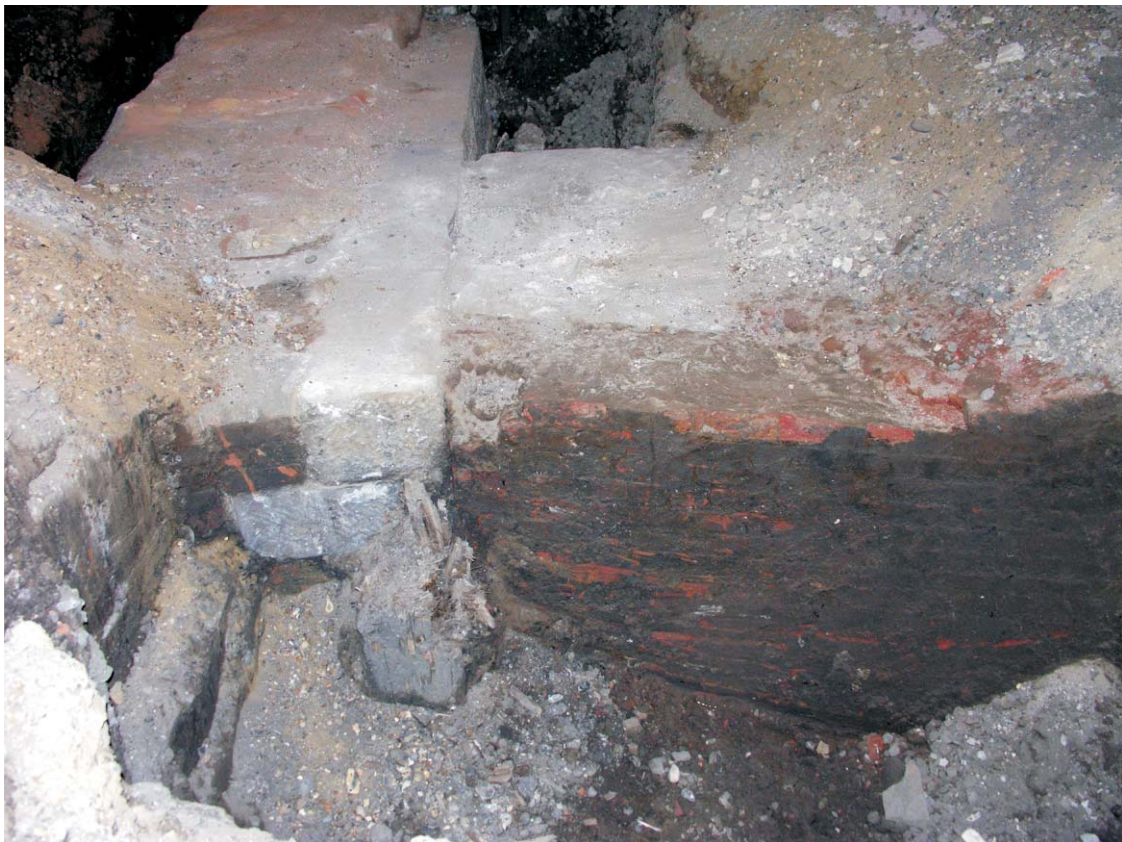
Fig 26 Dockyard Basin Wall in Trench 14, looking west. Brick wall [848] to right, stone wall [846] left

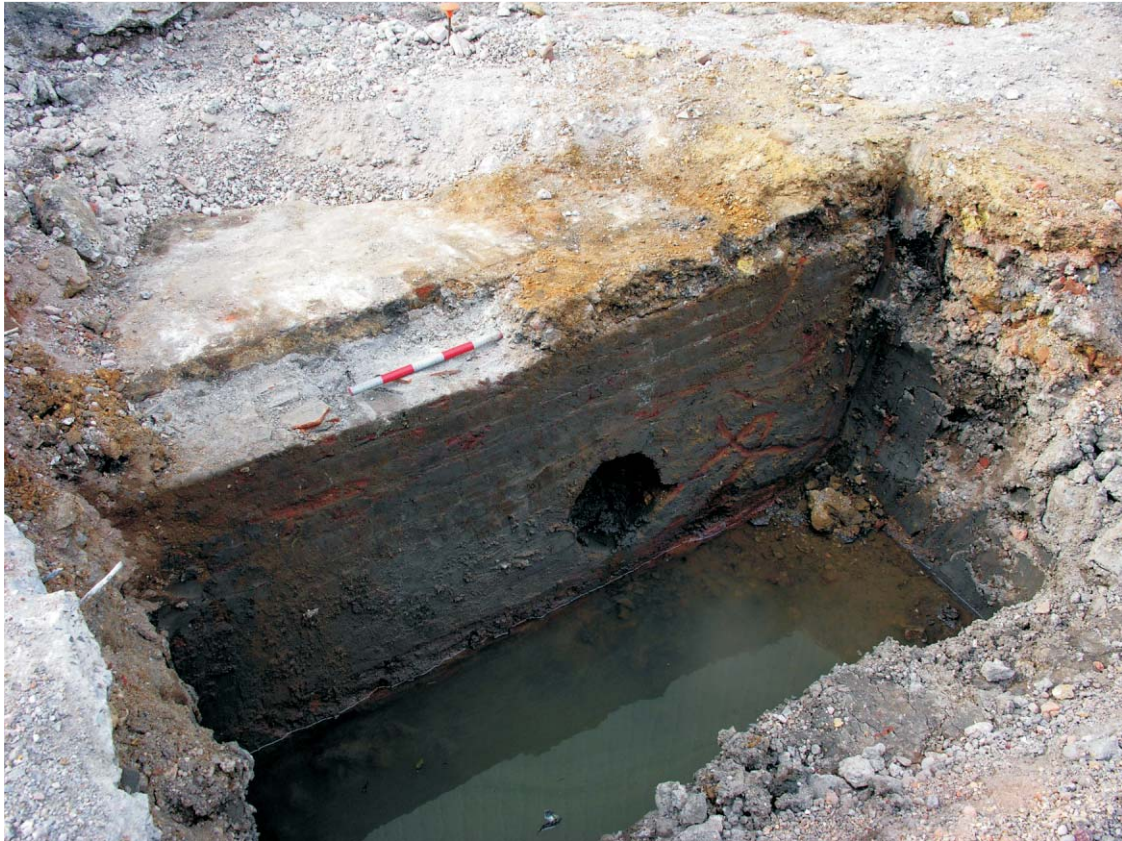
Fig 28 The Dockyard Basin wall [478] in Trench 19, looking northeast

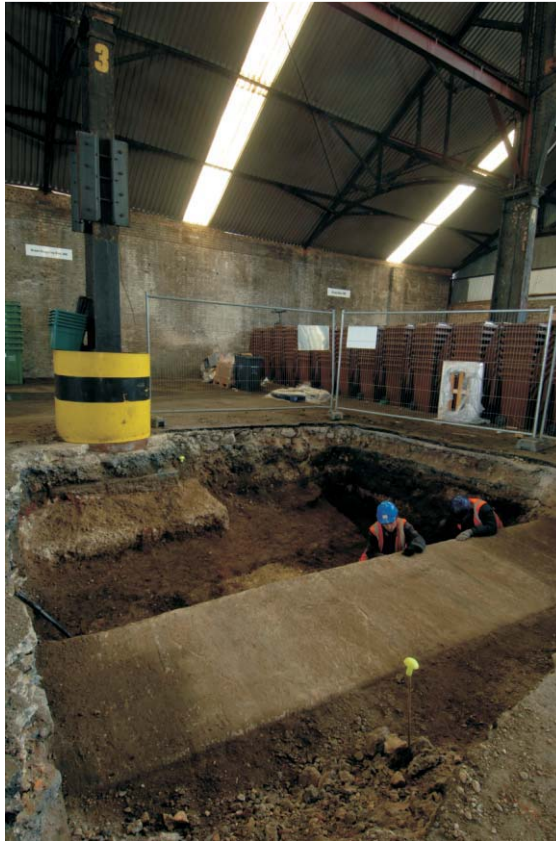
Fig 30 Part of stone slipway [488] and Olympia building foundations [487], seen in Trench 21, looking west

Trench 21 (Fig 29) was one of four trenches located in the 19th century cover building, Olympia, currently used as a warehouse. A granite wall [488] (Fig 30), interpreted as the wall to a slipway, ran north-south along the east edge of the trench. The top of this 1.14m wide wall lay at 3.00m OD. The foundation of one of the columns to the cover building lay within the trench. The iron column was supported on a series of concrete slabs (with some brick), a total of 0.90m thick [487]. The base of the concrete slabs lay at 2.06m OD.

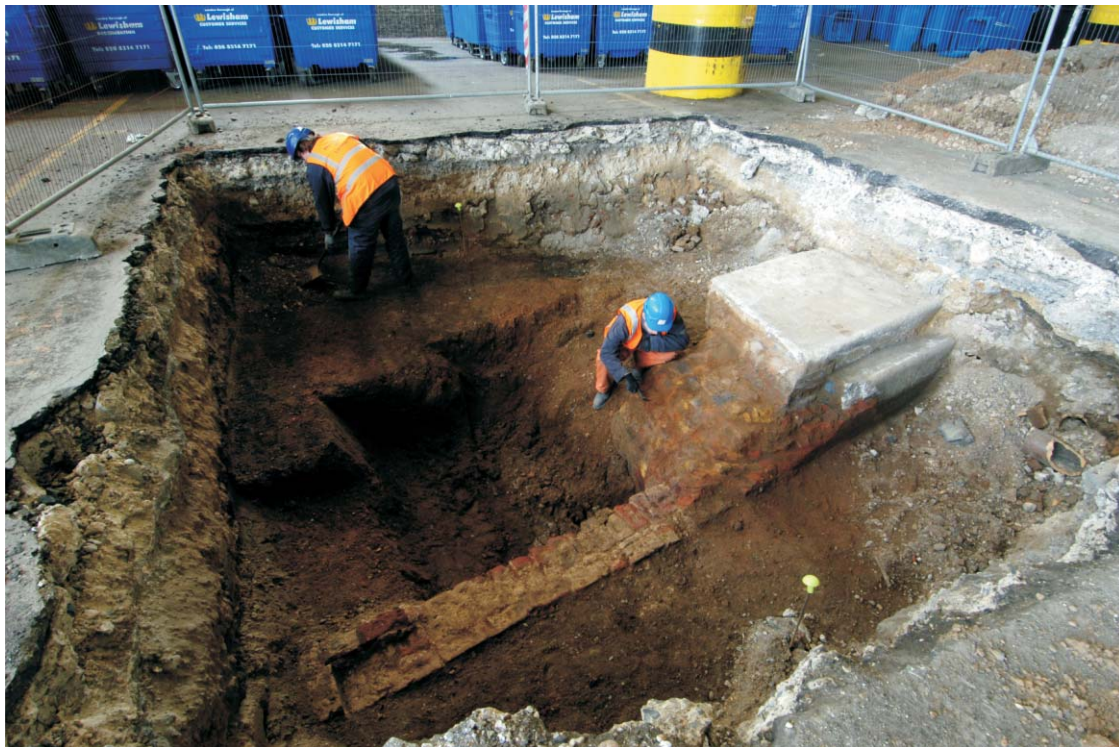
Fig 31 Part of stone slipway[492] in Trench 23, looking northwest

Trench 23 (Fig 29) was located in the Olympia building, and the southern end of the granite slip wall seen in Trench 21 was identified [492] (Fig 31). Its top lay at 2.92m OD and it was supported on a foundation of red and yellow bricks set in cement [493] which continued south as brick foundation wall [494]. A machine slot excavated
