3.2.26 Trench 26

3.2.27 Trench 27

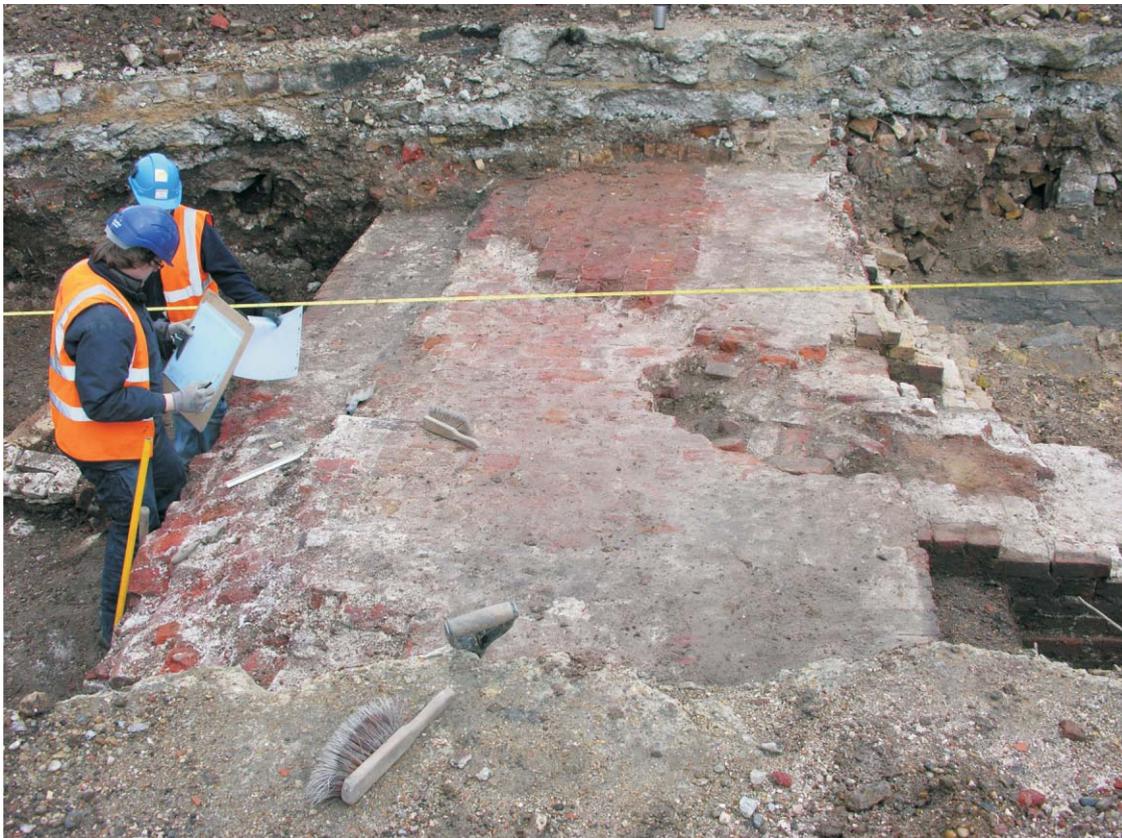
Fig 33 Brick structure [801] in Trench 25, looking north

out of use when later culvert [807], built of red brick set in yellow sandy mortar and truncating the walls, was constructed.

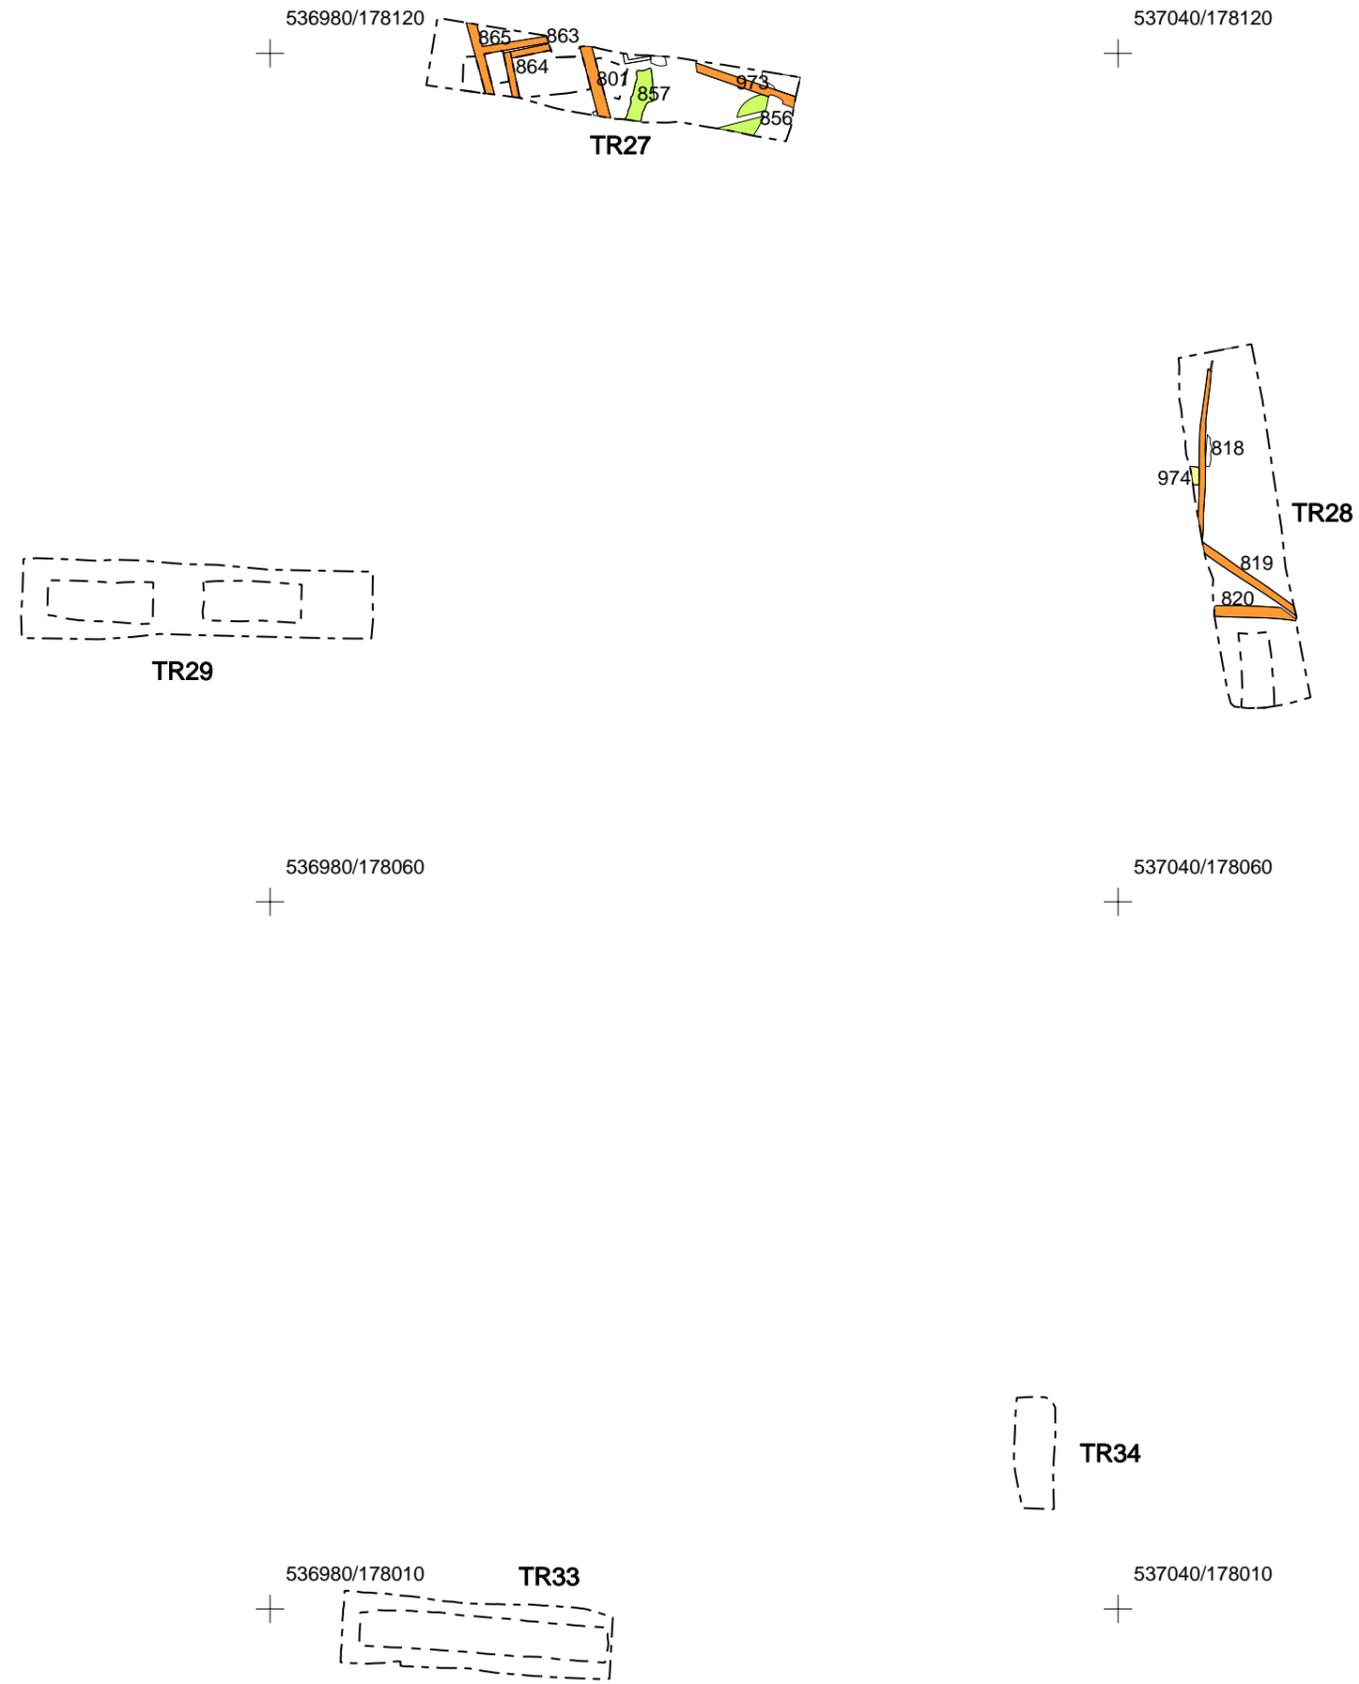
Fig 34 Trenches 27, 28, 29, 33 and 34

Trench 27 (Fig 34, Fig 35) contained at least five phases of walls and structures. The earliest seemed to be wall [864], built of red brick set in sandy mortar. This may have been the wall to a building or the Dockyard boundary wall, seen in the 1808 map as running through Trench 27. The northeast face of the wall was abutted by a red brick wall [863], set in off-white mortar, presumably of a second phase building added

No archaeological structures were identified in Trench 29 (Fig 34). A deep concrete slab occupied the west part of the trench, and a machine slot excavated to 3.39m OD in the east part of the trench also failed to locate any archaeological survival.

Pre-excavation CAT scanning of this trench, located in the western main access roads to the site, revealed a live electricity cable running across the north part of Trench 34 (Fig 34) and other services in the south part. The tarmac and concrete were broken out and careful machine excavation began in a central area of the trench. However, an iron water pipe and an electric cable were encountered in this area and excavation of the trench was halted.

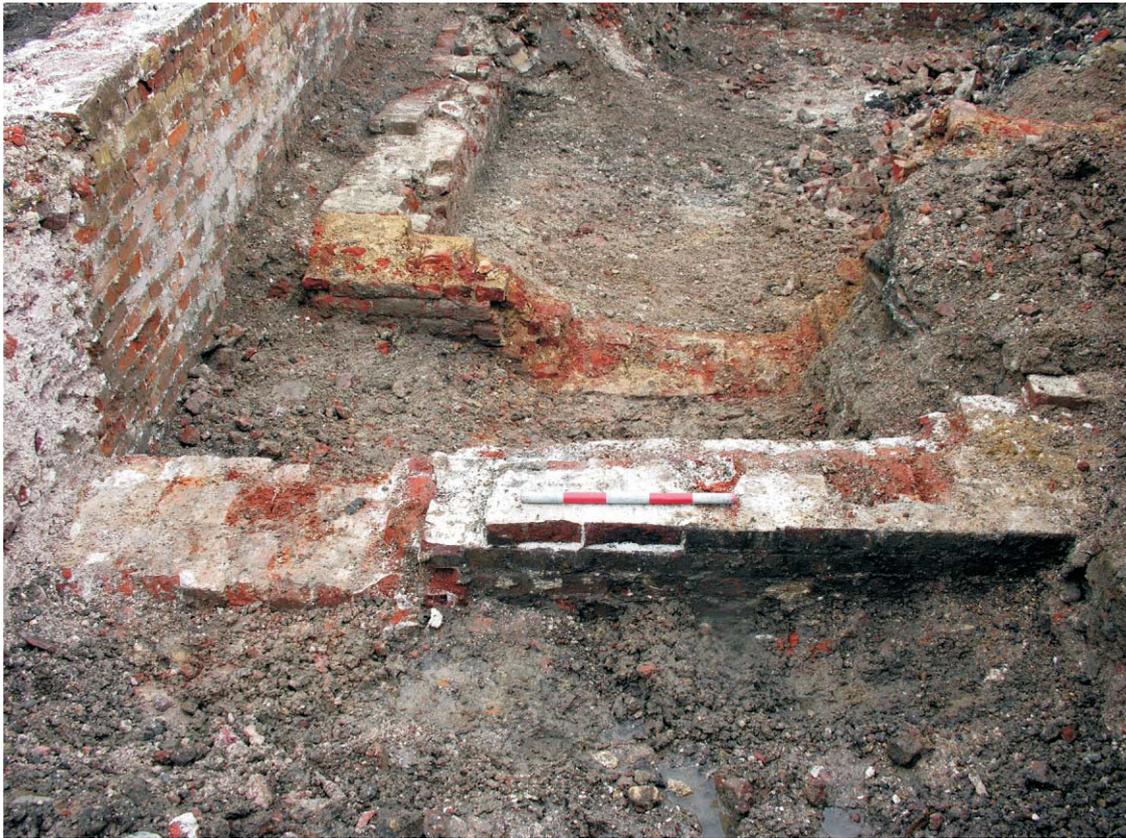
Fig 35 Trench 27, looking east. Wall [865] in foreground, earlier wall [864] behind

later. Both walls were truncated to a height of 1.28m OD, although the southeast end of wall [864] lay at 1.82m OD. The northwest end of wall [864] was truncated by wall [865] built of red brick set in white mortar, marking a third phase of building. The northwest part of wall [865] had been robbed out or removed later, the robber trench backfilled with brick rubble and mortar. To the east, wall [801] was the same build as wall [865] and the walls may have been part of the same building. Wall [865] survived to 2.34m OD, wall [801] to 1.45m OD. An external surface survived to the east of wall [801] built of angular stone [856] and [857] at 1.64–1.83m OD.

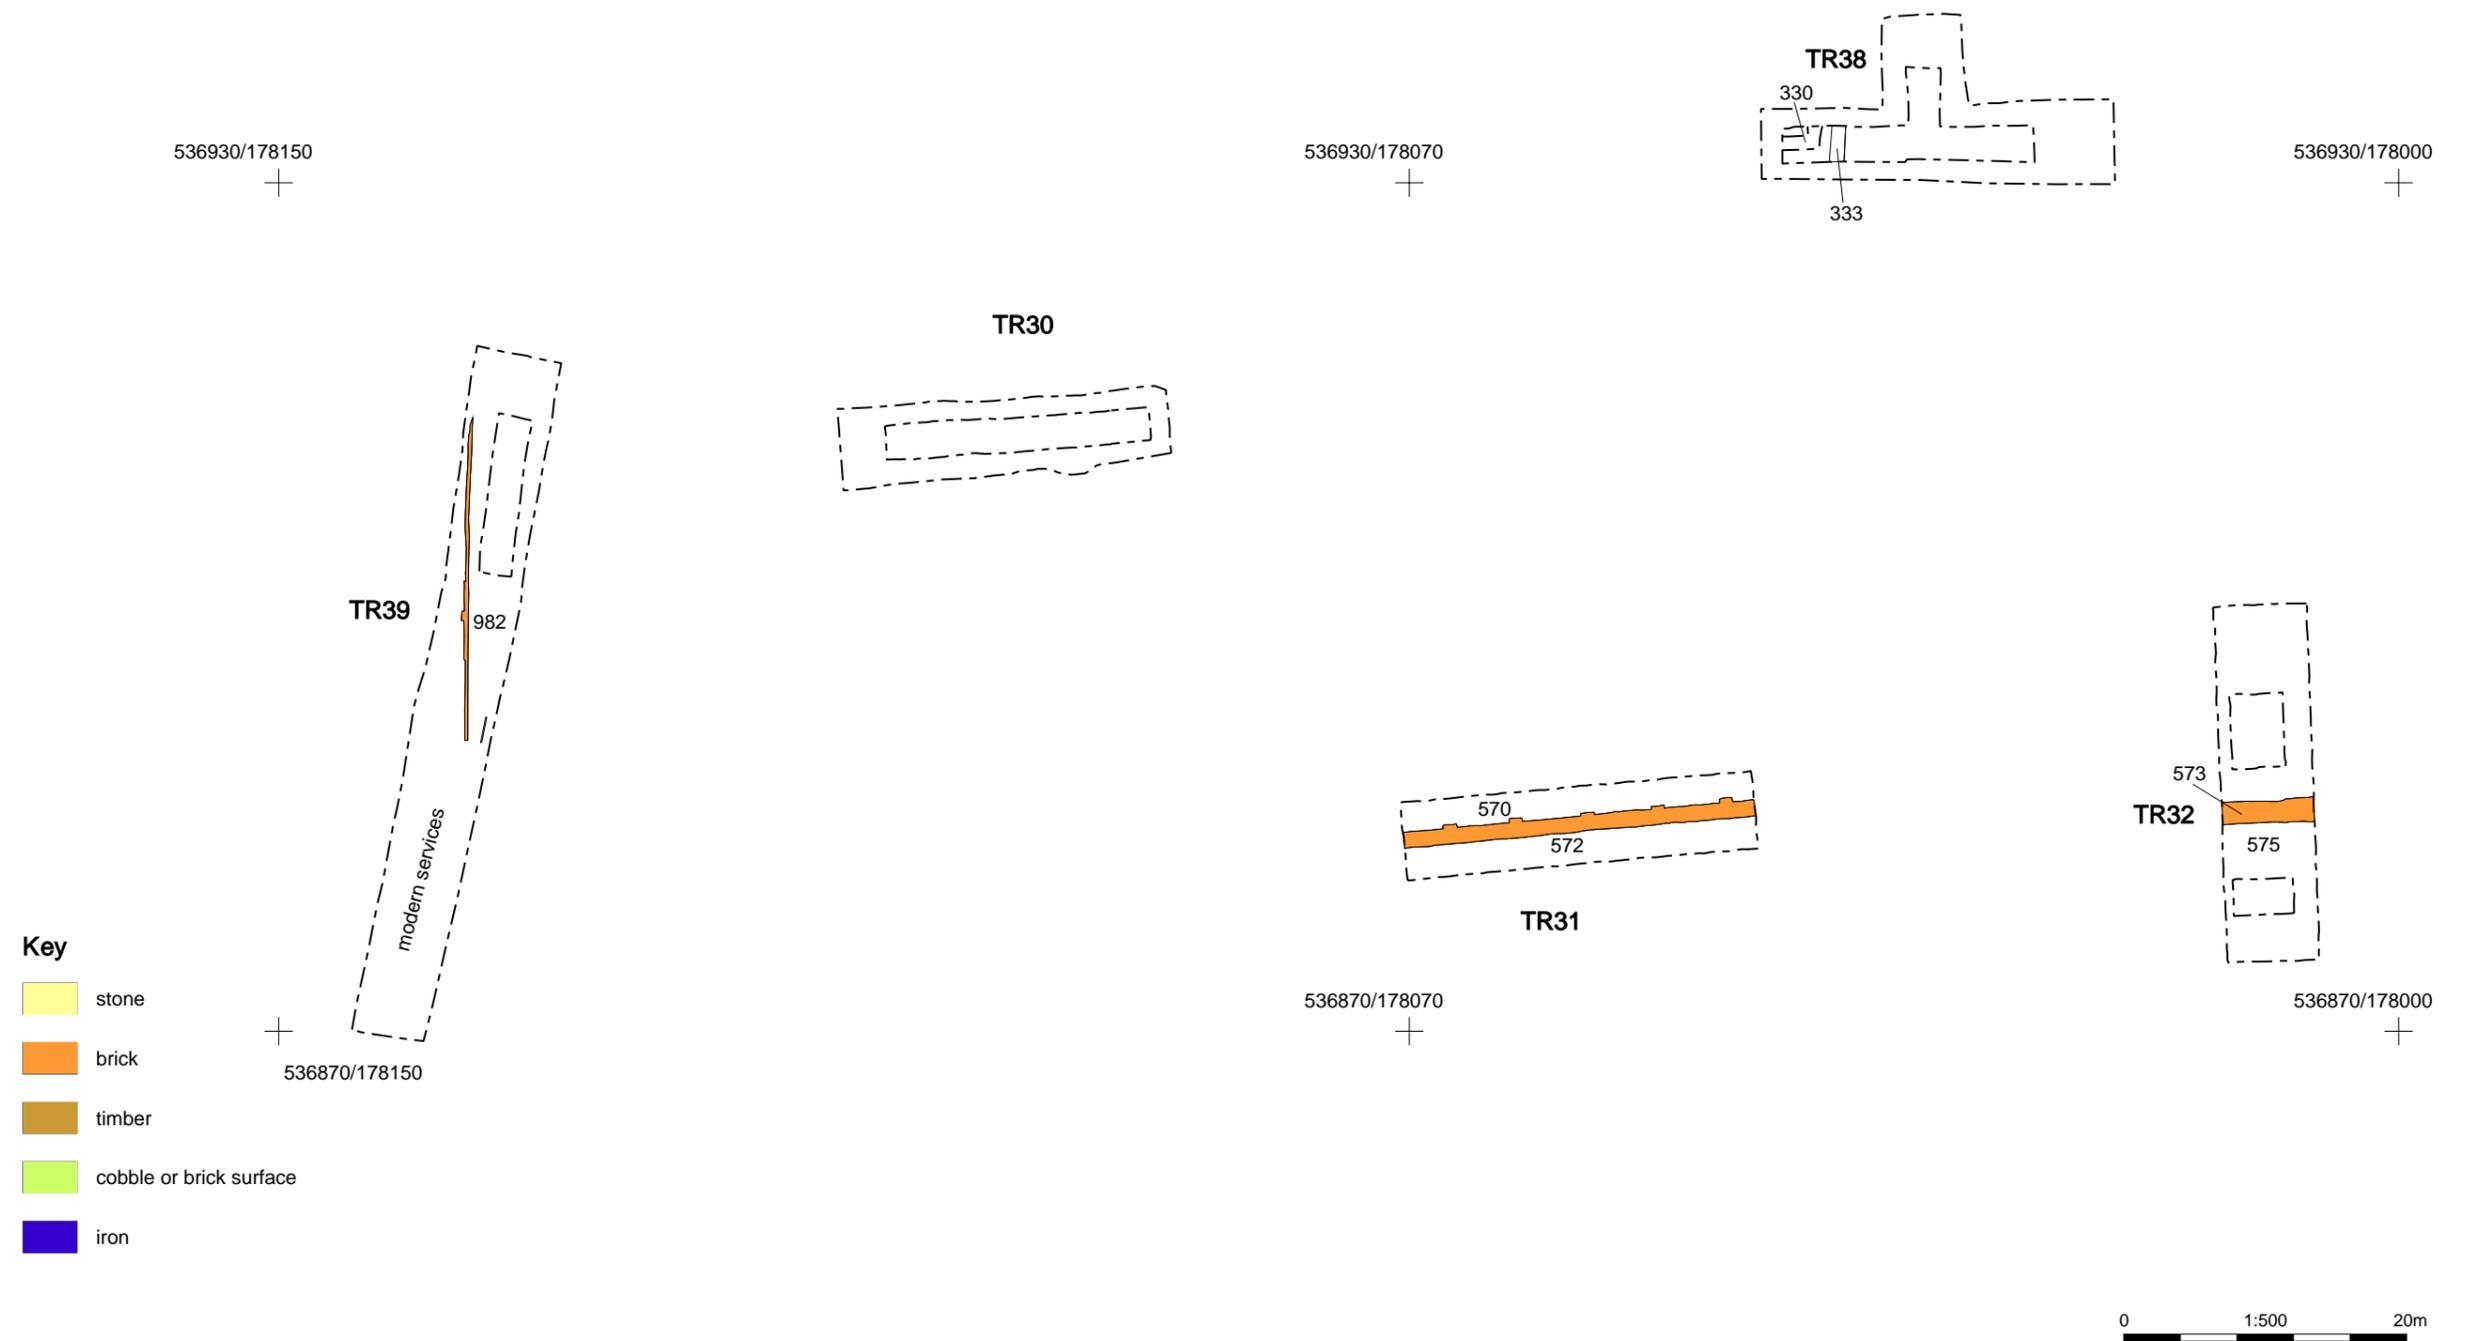
Fig 37 Trenches 30, 31, 32, 38 and 39

The wall and granite sets observed in Trench 31 (Fig 37) continued into Trench 32 ([573] and [575] respectively). Unlike Trench 31, Trench 32 was at right angles to

wall [573]/[570] which facilitated deeper excavation with the machine. Two machine slots were excavated either side of wall [573]. Natural sand and gravel was recorded in the slots at 2.29m OD.

Natural sand and gravel was encountered at 2.05m OD in a machine slot excavated in the east part of Trench 39 (Fig 37). The natural was sealed by a series of dumps or levelling deposits of dark sandy silts with occasional brick and tile fragments to a height of 3.40m OD, which were themselves sealed by modern make-up deposits and a 0.30m depth of concrete slab. A thin wall [982] built of yellow brick ran along much of the length of the trench and may have dated to the early 20th century. The broken top of the wall lay at 3.37m OD. The west part of the trench was inaccessible because of modern services.

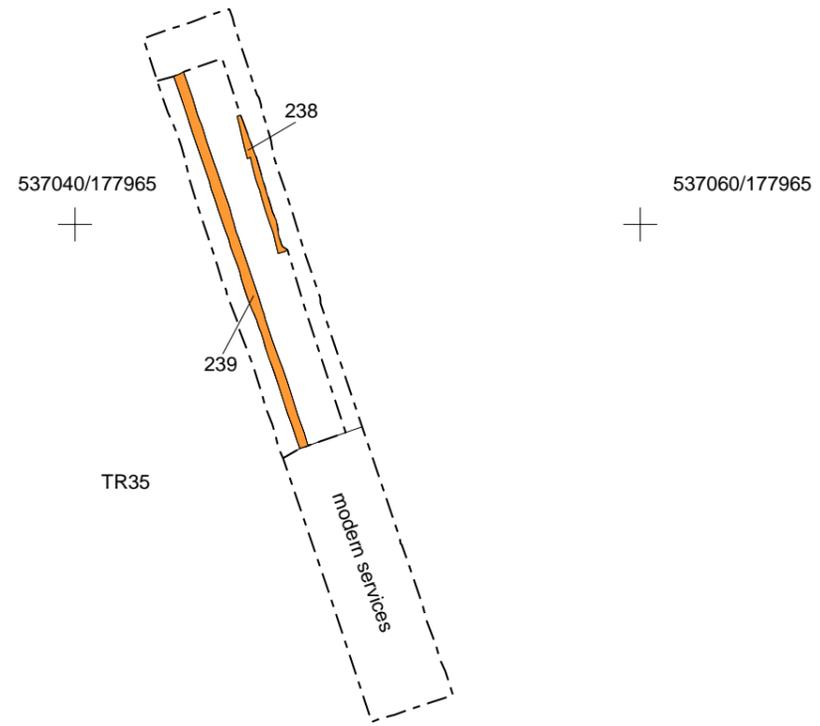
Two walls were identified in Trench 35 (Fig 40), both running along the north-south trench. The earlier wall [238] was built of purple-red bricks set in white mortar. The

upper part of the wall overhung the lower part, suggesting the wall was likely to have been the east edge of a culvert, the west edge having been lost. The top of the wall lay at 3.32m OD. Only the east face of the later wall [239] was exposed. The wall was built of shallow frogged yellow bricks set in grey cement and its broken top lay at 3.98m OD. Modern services in south part of the trench prevented excavation.

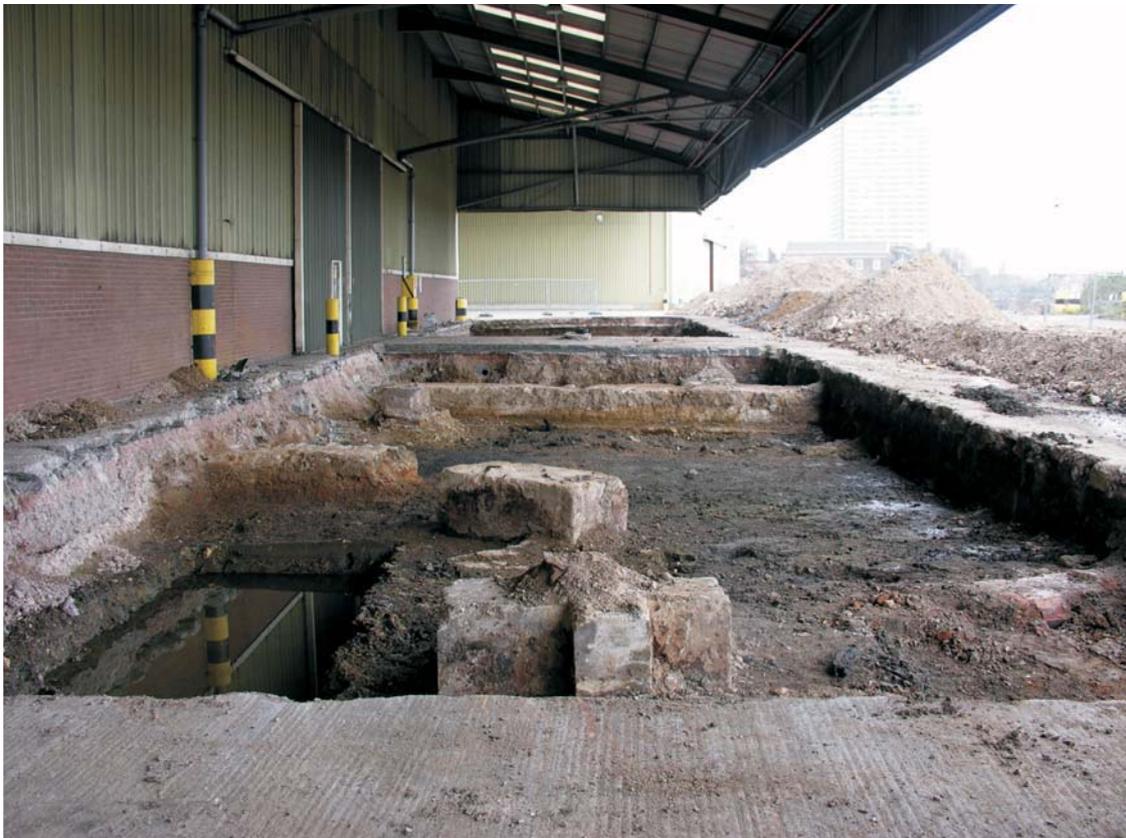
Fig 42 Trench 37, looking northwest

Trench 37 (Fig 19, Fig 42) was located immediately southeast of Trench 11 and northeast of Trench 12. Unlike Trench 12, however, the fragmentary timbers uncovered in the trench were difficult to interpret as a slipway. Deeper slots excavated in the south and northern parts of the trench, to 3.20m OD and 3.55m OD respectively, failed to locate any further timbers. Any remains of the slipway seen in Trench 12 may have been removed by a line of modern concrete piles to the north of wall [875]. Wall [875] was built of yellow brick set in grey mortar and was likely to have been the wall shown on the 1916 map (Fig 71) crossing the northwest part of

the trench. A patch of cobbles [876] at 4.35m OD is likely to have been a survival from the Dockyard phase of the site.

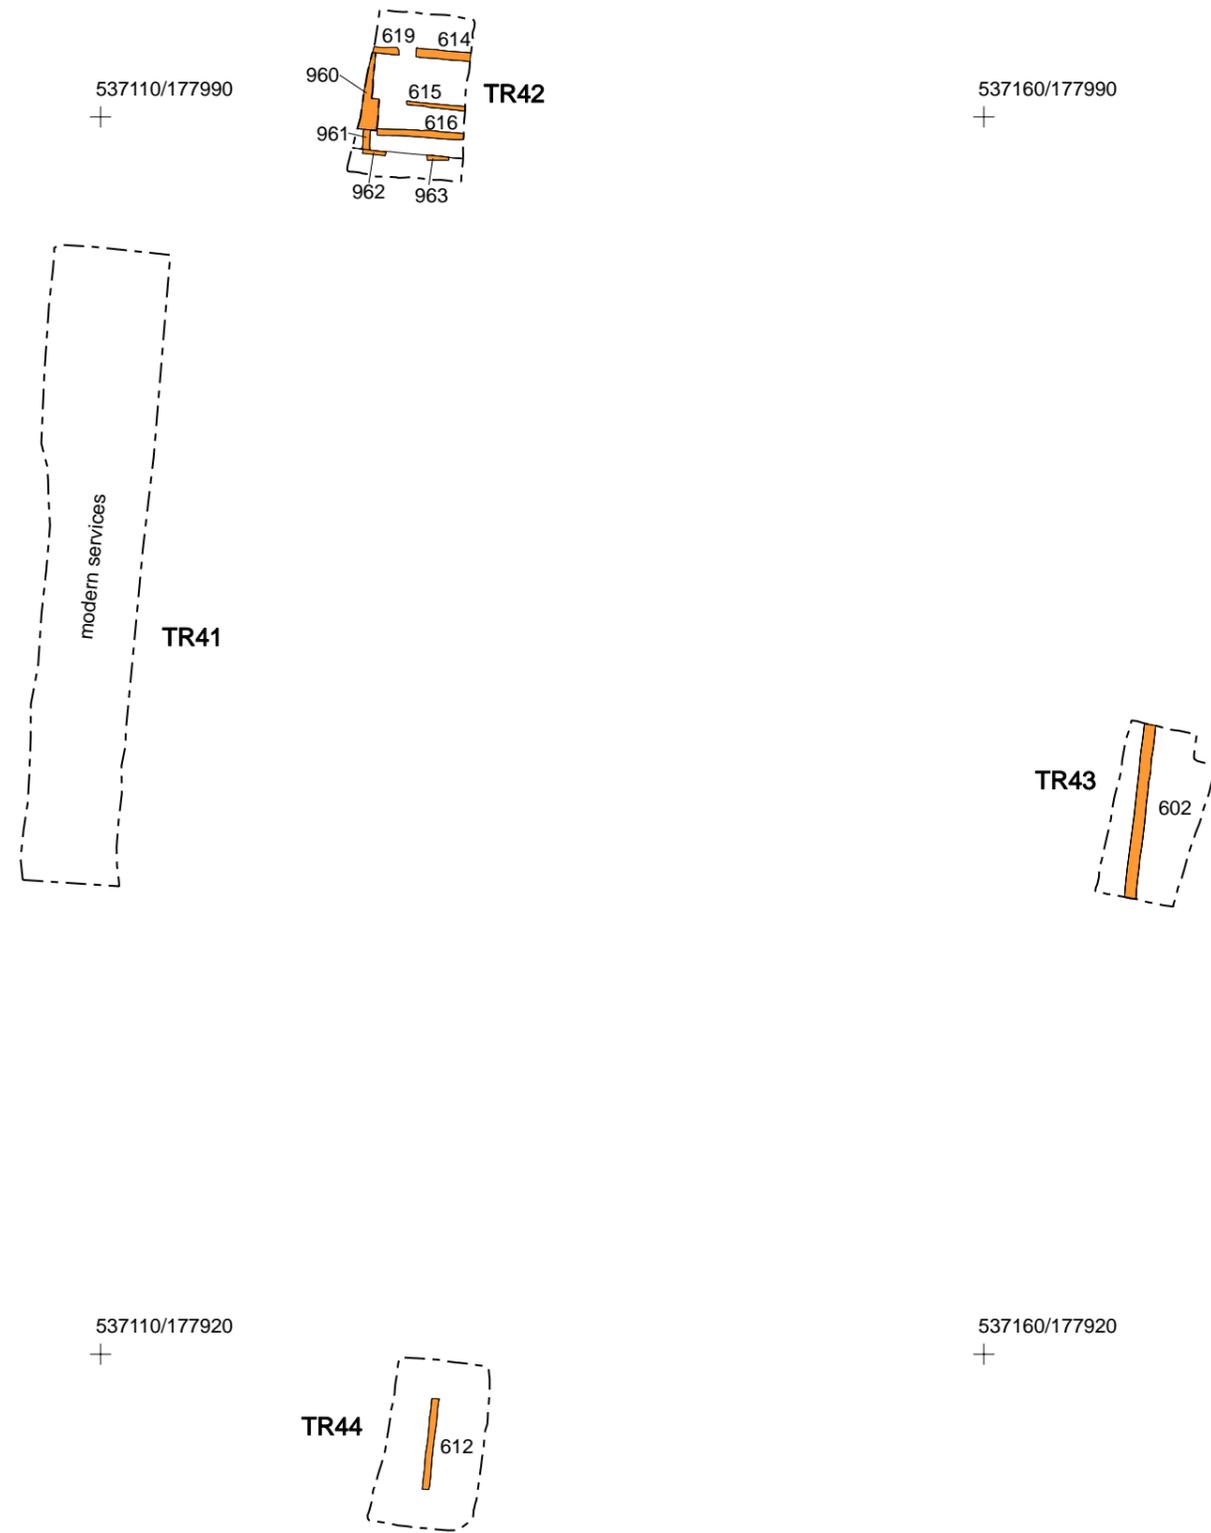
Fig 44 Trenches 41, 42, 43 and 44

Pre-excavation CAT scanning of Trench 41 (Fig 44), located in the eastern main access roads to the site, revealed a live electricity cable running along the west side of the trench and a water pipe running along the east side. The tarmac and concrete were broken out and careful machine excavation began in a central area of the trench that seemed clear. However, an iron water pipe and telephone cables were encountered in this area and excavation of the trench was halted.

Four phases of building were observed in Trench 42 (Fig 44). The earliest phase of wall [616] had been demolished to make way for a second phase building consisting of walls and structures [614], [619], [960], [961]. A possibly internal wall [615] added to this building represented a third phase. In the fourth phase, the southern exposed wall of the building was rebuilt as walls [962], [963]. Surfaces, possibly associated with the second phase building and the fourth, were also identified.

The only historic structure identified in Trench 43 (Fig 44) was a north-south running wall [602]. This wall was built of red bricks set in greyish white lime mortar, its broken

A north-south running wall [612] was identified in Trench 44 (Fig 44), built of red brick set in white lime mortar. The wall had been truncated at either end by modern concrete piles and its broken top lay at 4.16m OD. The trench was filled with demolition deposits of brick and cobble rubble below 0.90m deep modern make up and 0.16m deep concrete slab.

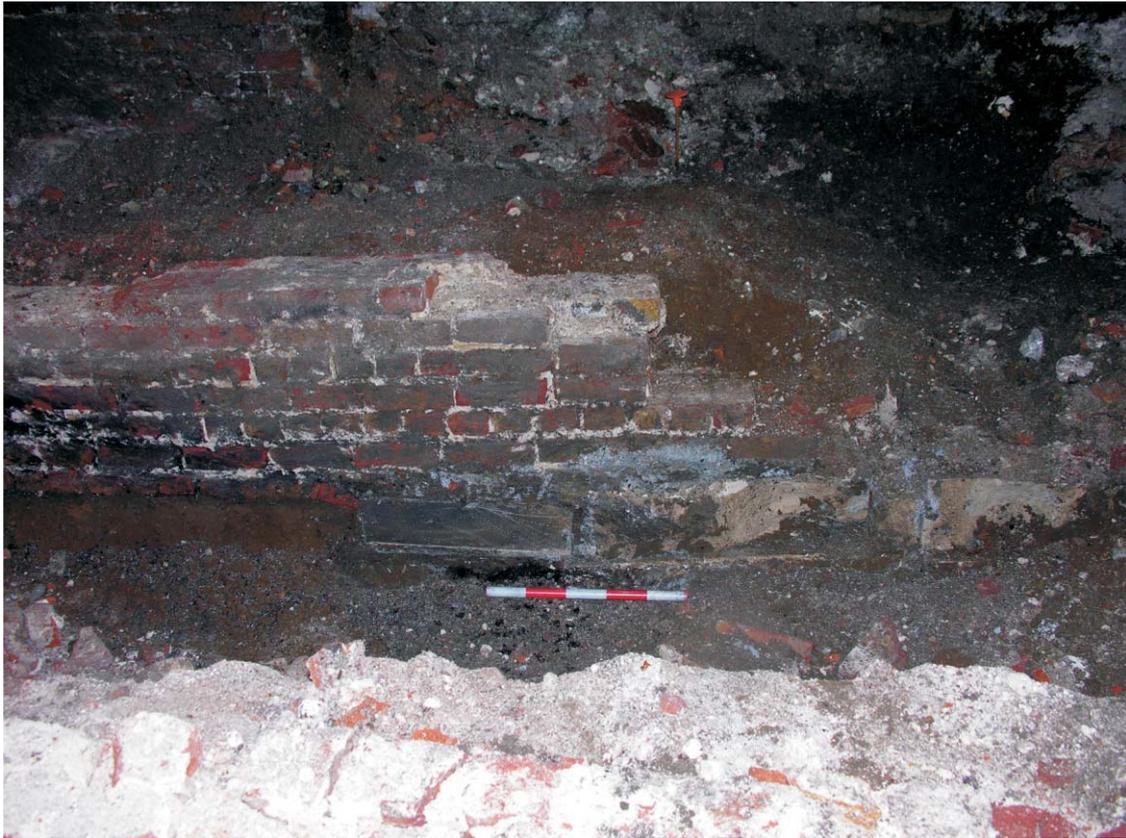
Fig 46 Reused stone in foundation of wall [616] in Trench 42, looking south

Once the 0.20m concrete slab and building demolition that filled the trench were removed, a series of walls was revealed. The earliest of these [616] was exposed 0.29m deep and built of red-purple bricks set in white lime mortar. The broken top of wall [616] lay at 3.79m OD. Its foundation consisted in part of re-used stone, including an ashlar block measuring 0.53m by 0.16m (Fig 46).

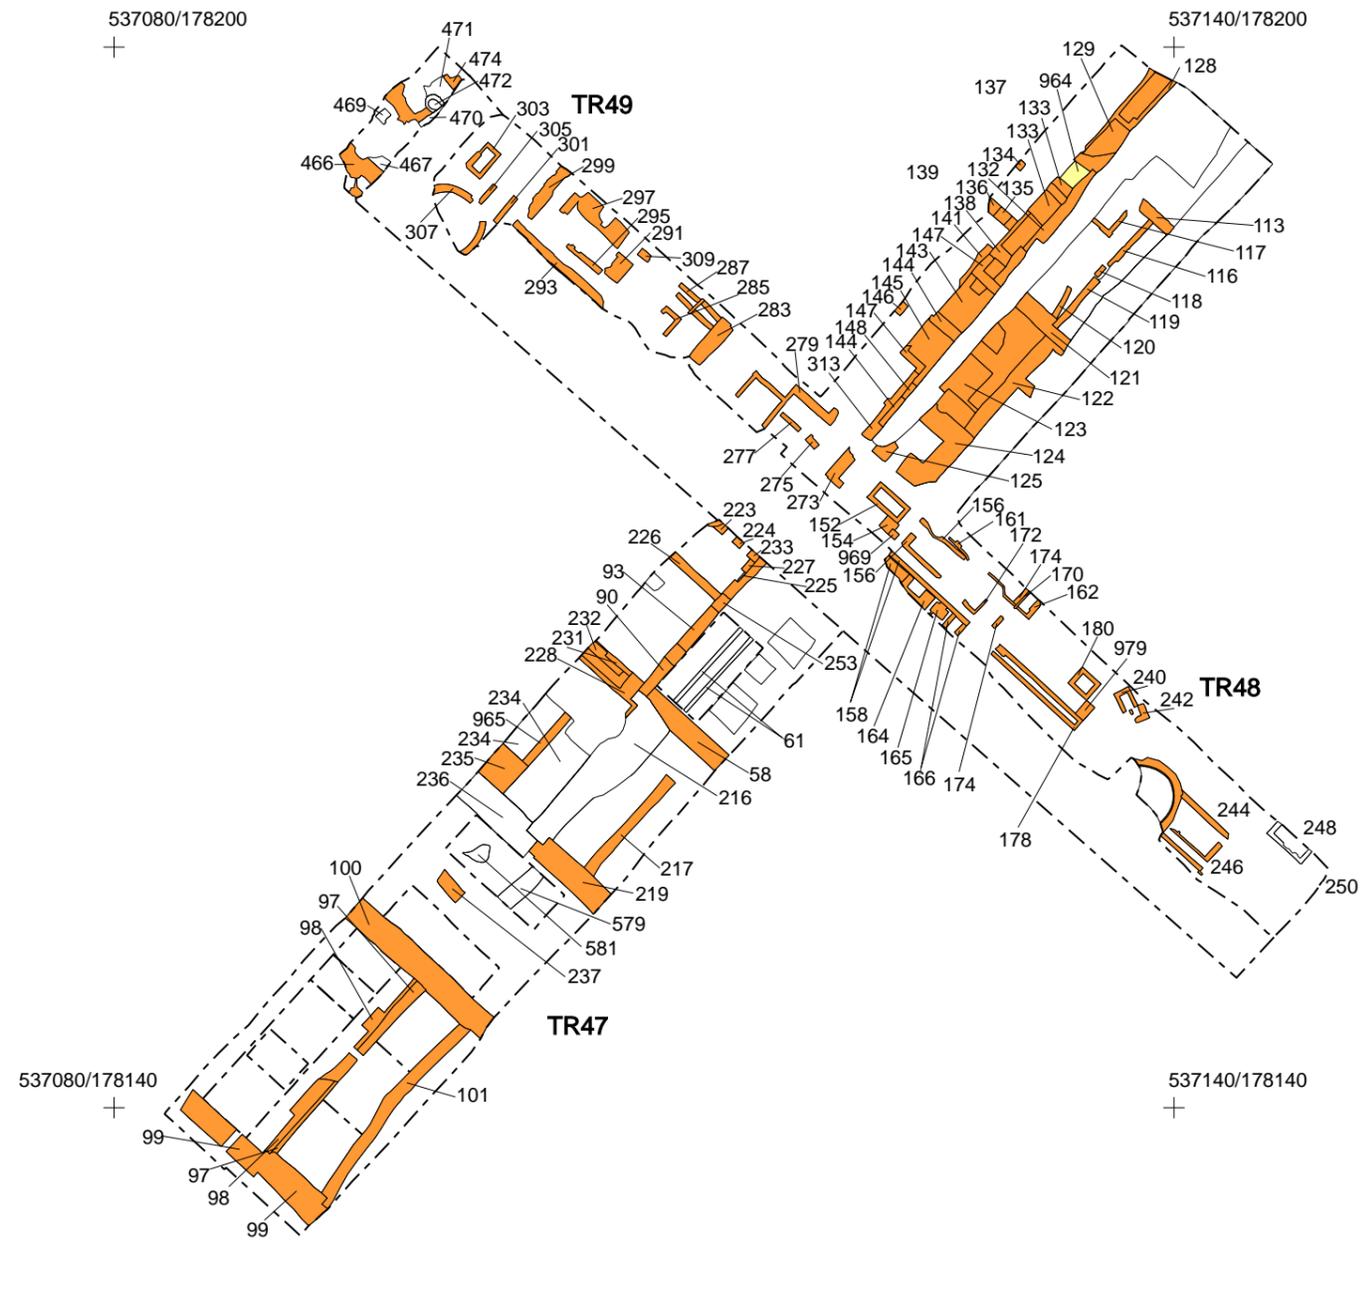
Fig 48 Trenches 47, 48 and 49

The earliest group of structures in Trench 49 (Fig 48, Fig 53) may have related to the Boat House known to have been located in this area of the site from map evidence. Tile floor [474] lay at 3.27m OD (Fig 54). Very fragmentary wall foundations survived nearby [469], [470] and [471], and the possible mortar packing for a post [472].

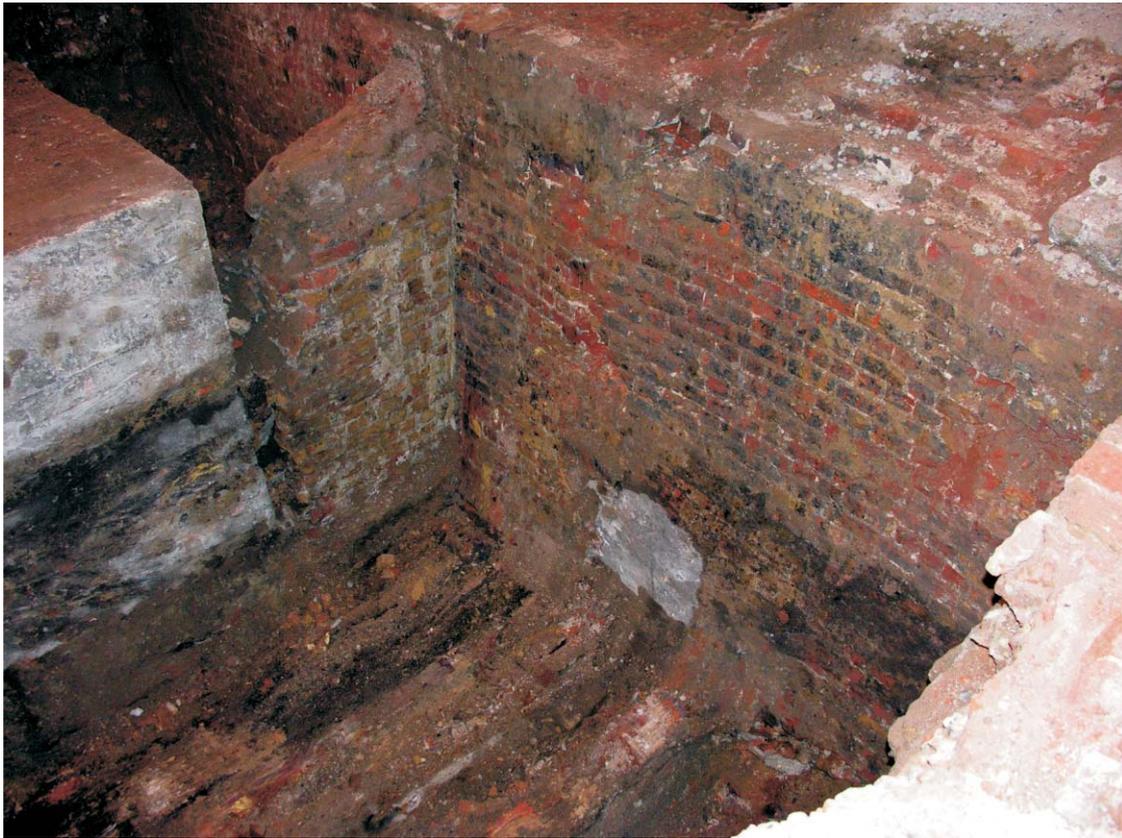
Fig 51 Deep truncation in the south part of Trench 47,north of wall [058] image looking south

A machine slot was excavated in a large area devoid of structures to the northeast of wall [058] to investigate any underlying stratigraphy or structures. The slot was 3.7m deep, to a depth of 1.20m OD (Fig 51) and revealed an iron pipe within the walls of a broken-topped culvert [061]. This iron pipe, presumably for discharging foul water into the Thames, was seen to continue further southwest as well as northeast, capped by concrete (and removing any underlying archaeological structures or deposits). This area of deeper excavation also showed that the springing for a brick arch had been inserted into wall [093], indicating this area of the building had been vaulted (the principal axis of the vault running northeast-southwest). On the southwest side of wall [058], remains of a springing were also visible on wall [217].

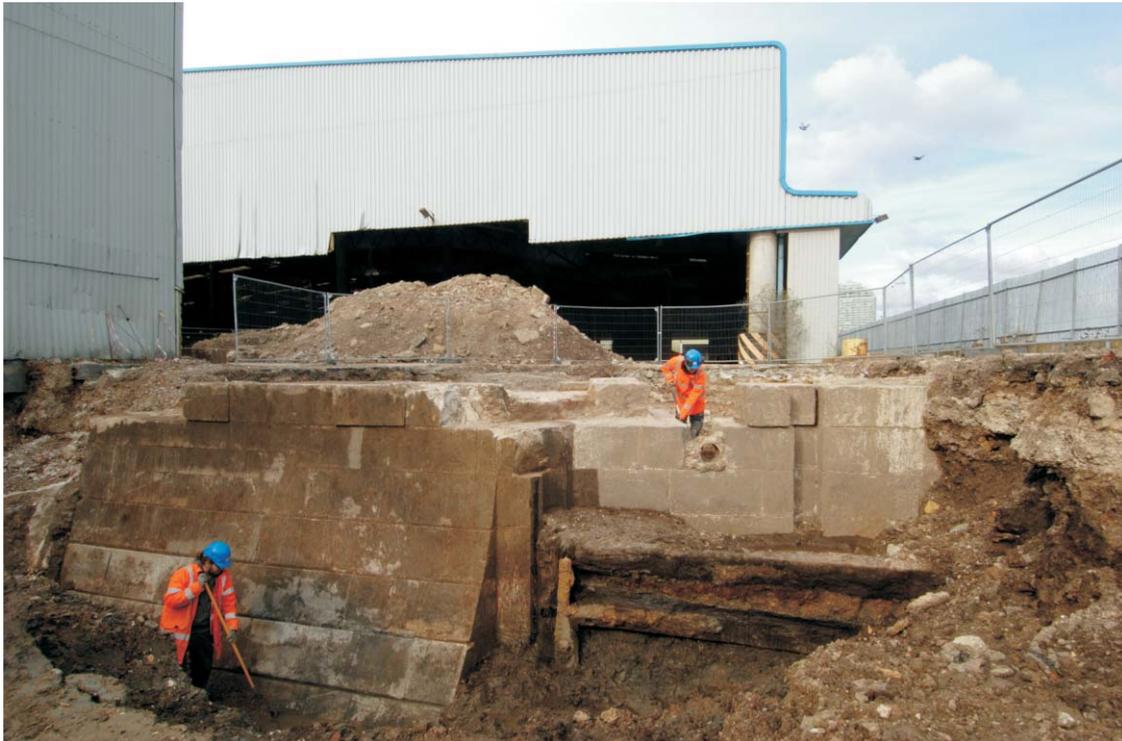
Fig 56 West wall [457] of the Great Dock in Trench 50, looking northwest. Iron and timber dock gate to right

The upper parts of the massive gate [451] of the Great Dock were exposed, comprising partially decayed oak beams and uprights of its iron frame. Thick cream paint on one of the beams suggested reuse. The oak was fast-grown and probably of British origin, perhaps surprising as in the mid 19th century more rot-resistant tropical timber species were used (Damian Goodburn pers comm.). The gate had evidently become dislodged from the semi-circular recess cut into the stone.

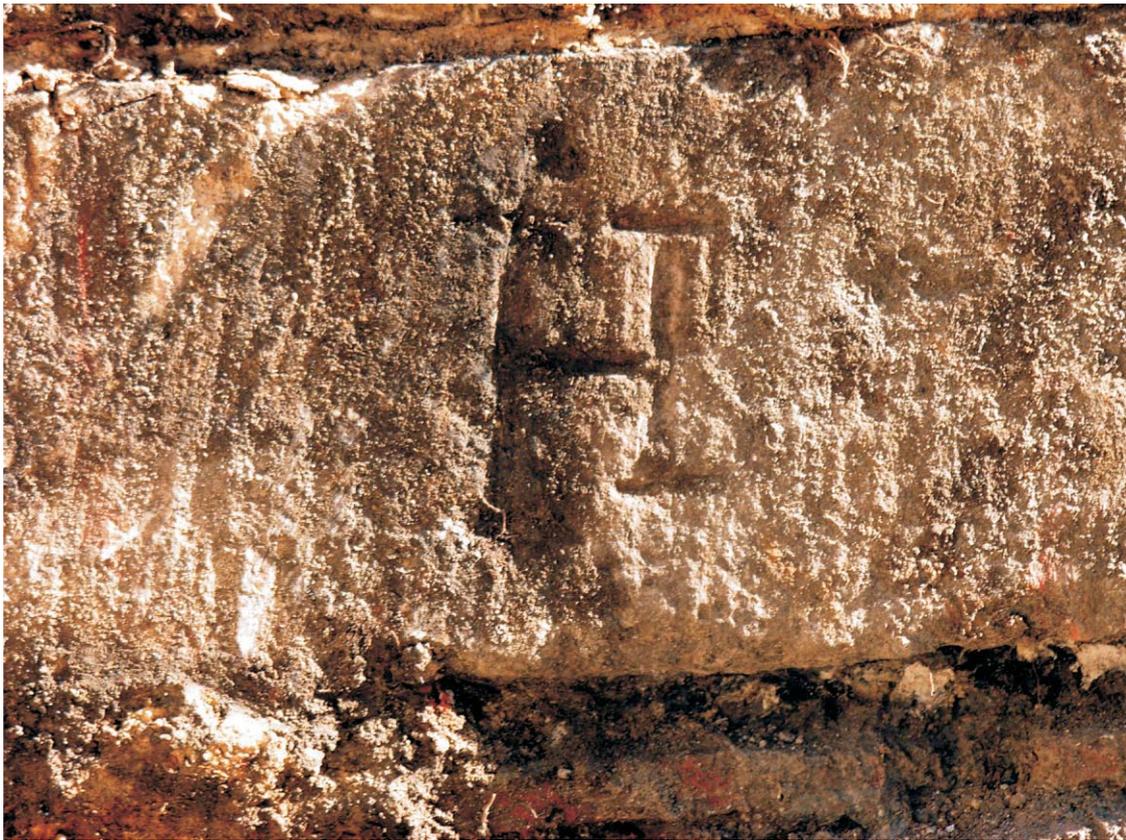
Fig 58 Mason's mark or graffito ('H') on Great Dock Wall [457] in Trench 50, looking northeast

The south end of the Great Dock west wall was stopped, and a mason's mark or graffito (an 'H', 74mm high and 52mm wide) had been carved into a stone in the end (Fig 58). An area of mortar-like white concrete [456] abutted the Great Dock here, with recesses visible, some of which still contained rotted timber, for a land-tie arrangement. A large stone was still *in situ*, embedded in the backfill of the Dock, where it had fallen – presumably when this early concrete failed or the land ties rotted.

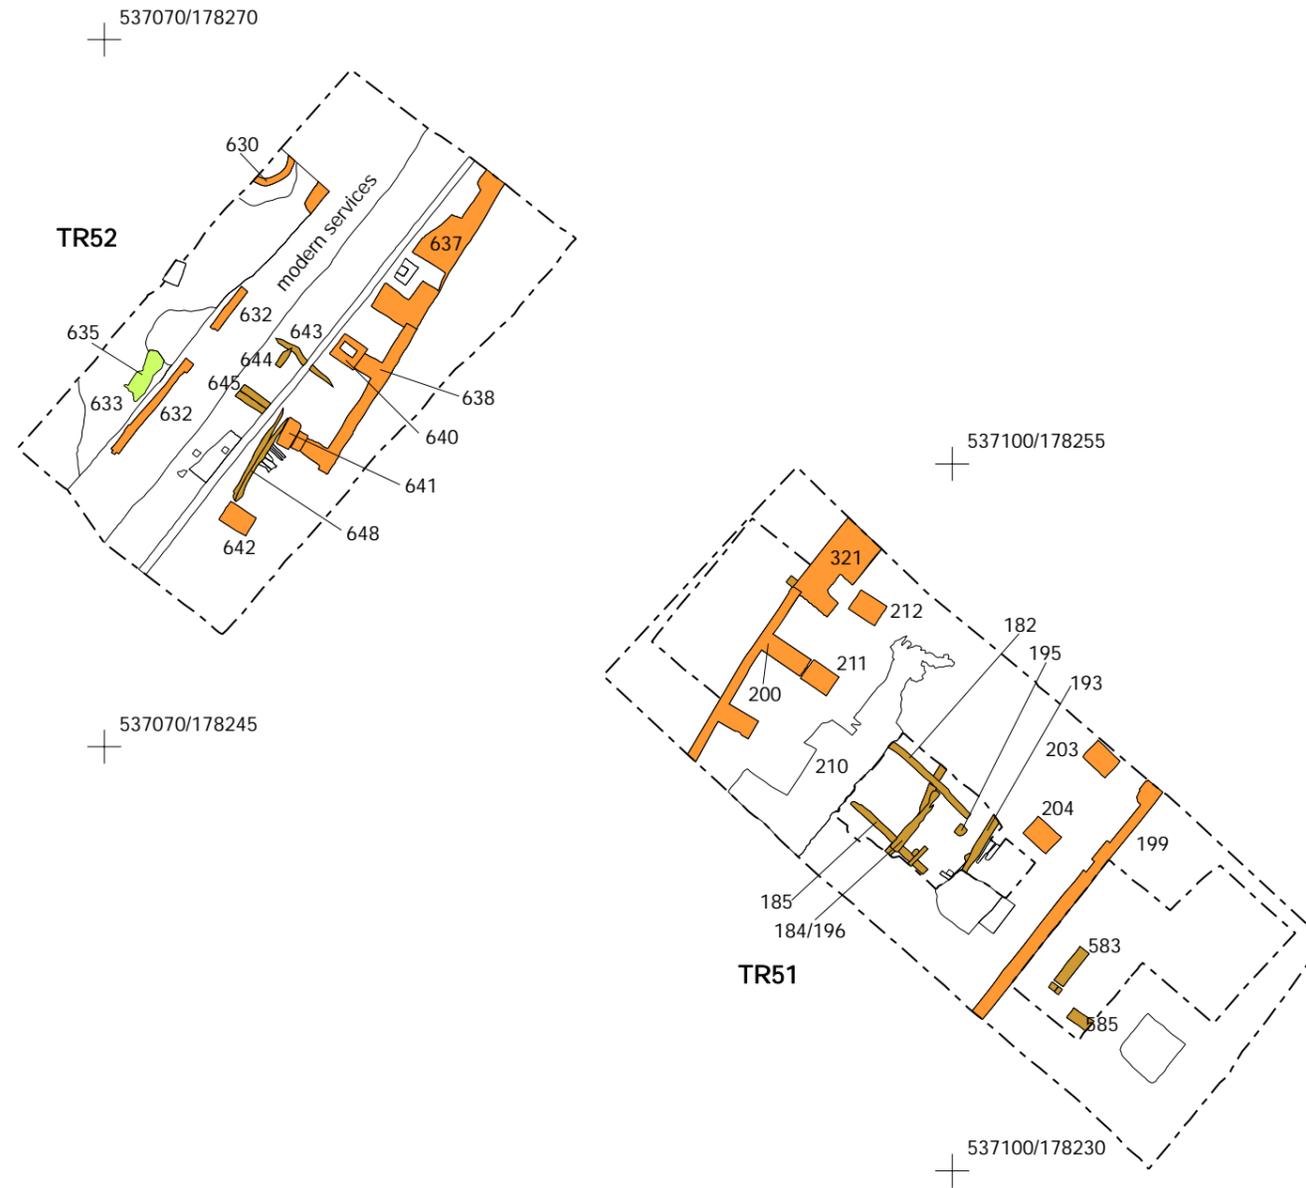
Fig 59 Trenches 51 and 52

The earliest structures in Trench 51 (Fig 59, Fig 60) consisted of a gridwork of substantial (200mm, sub square or roundish) oak beams ending to the west against a mass of dumped chalk rubble [210]. The northwest ends of the pair of northwest-southeast beams [182], [185] had decayed off but the remains of a dogged-on, wrought iron tie was visible on each. The iron ties acted to strap the land-tie beams to now decayed posts of a dock inlet which was extant when the chalk was dumped in. Unusually, iron spikes (large nails) which once held the plank sheathing of the dock inlet to the posts were still *in situ* in the chalk (Fig 62), despite the sheathing plank having rotted away. Beams [182] and [185] were jointed or fitted with a lock bar and anchor stakes to resist land-fill pressure pushing northwest.

The central part of Trench 52 (Fig 59) was inaccessible because of modern services. It was therefore difficult to assess structures partially hidden by the services or later walls. Timbers [643], [644], [645] and [648] may have been tie-backs, as seen in Trench 51, or the fragmentary remains of early slipways. Similarly, chalk deposits, for example [633] in the northwestern part of the trench (Fig 65), may also have been slipway remains or dumps of chalk. Some surfaces were identified: an area of cobbles [635] in the northwest part of the trench at 3.63m OD, and flagstones [641] in the southeast part at 3.45m OD. The slipway wall [637] (Fig 64) in Trench 52 was the corresponding wall to Slipway No 4 as wall [200] identified in Trench 51. The northeast part of wall [637] was earlier than the wall [638] that abutted its southwest stopped end. The corresponding cover building foundations were also identified: [639], [640] and [642]. A well [630] was identified in the northwest corner of the trench at 4.21m OD and a fragmentary yellow brick wall [632] surviving to a similar height.

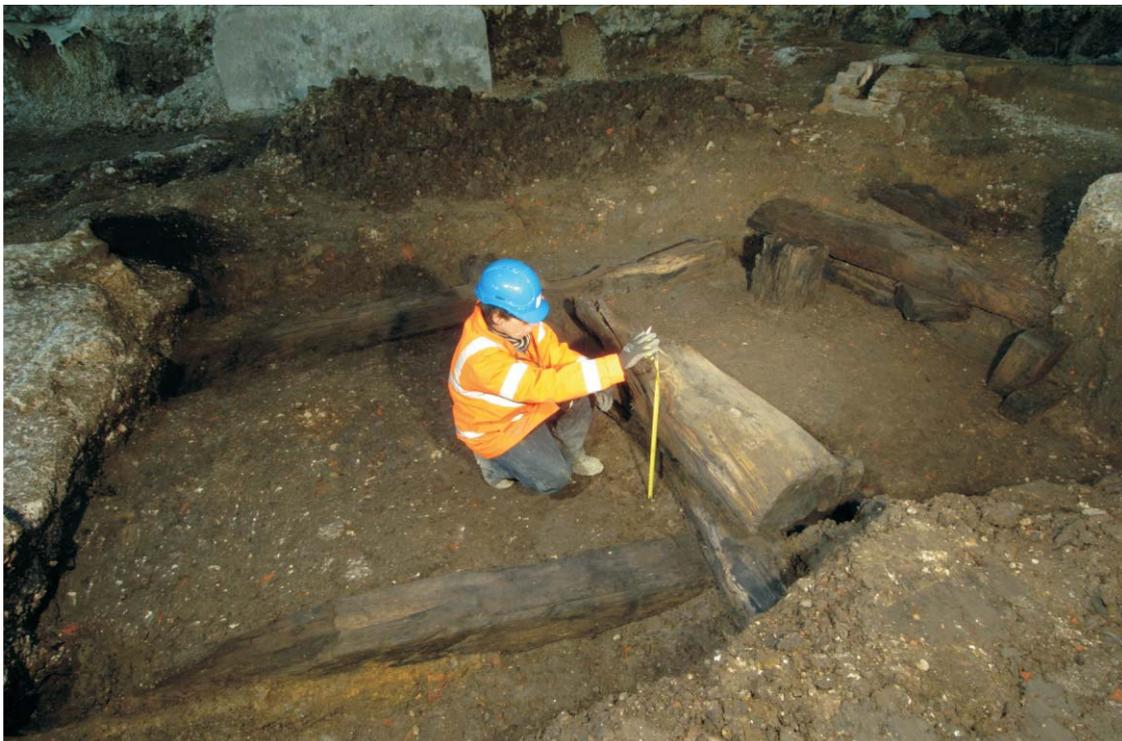
Fig 61 Timber tie-backs in Trench 51, looking northeast. Iron rod and reused deck beam [185] in foreground

The southern most beam [185] (Fig 61) had a bead moulding on an aris and three shallow housing joints showing that it was originally a large ship deck beam whilst the northern beam [182] was a minimally trimmed log. Two northeast-southwest beams [184]/[196] and [193] were jointed or fitted with a lockbar and two anchor stakes showing that they retained the contemporary river wall to the northeast (not seen in the trench). Both these beams had been doubled over showing long term use and repair. The isolated large oak upright [195] may have been part of simple pole crane or support for a temporary building (Damian Goodburn pers comm.).

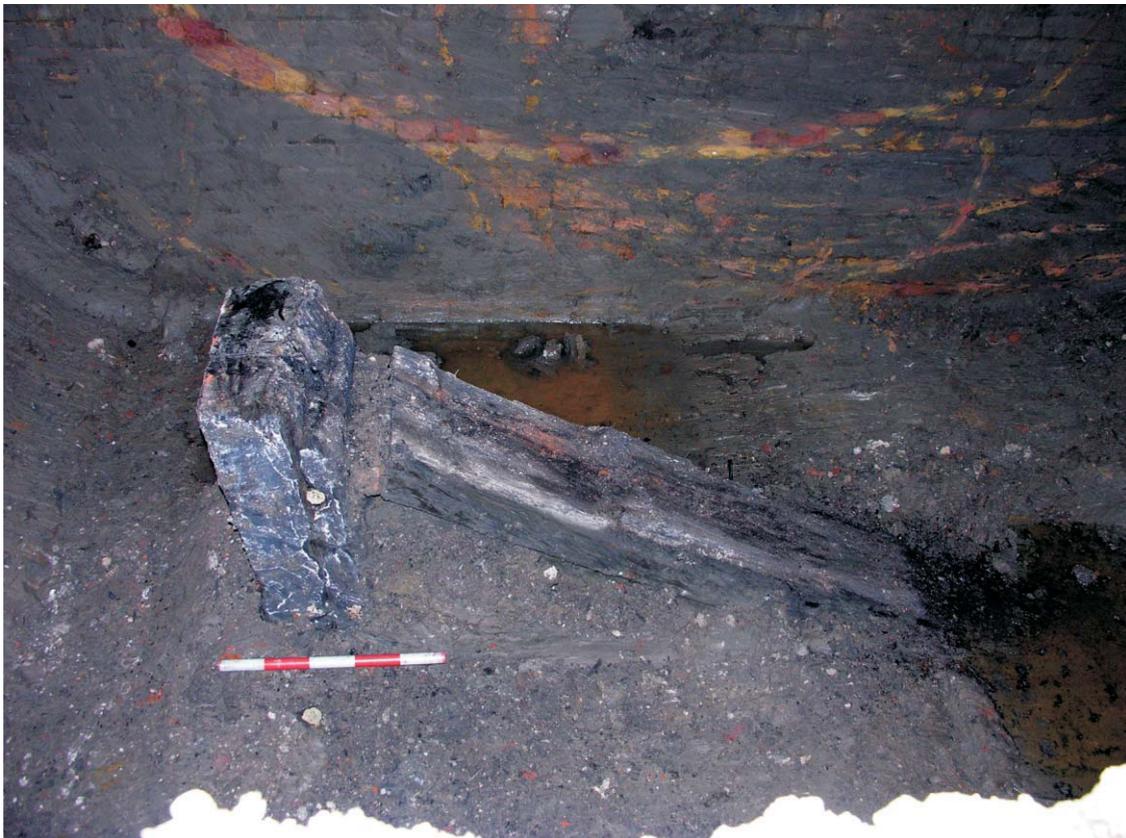
Fig 63 Timber brace [582]/[583] in slipway in Trench 51, looking northwest

consisted of a vertical post, exposed 0.77m high, with a second timber, exposed 1.58m long, sloping down from the top of the vertical post (Fig 63).
